# Performance of Batten Columns in Steel Buildings During the Bam Earthquake of 26 December 2003

**B. Hosseini Hashemi and M. Jafari S.**

Structural Engineering Research Center, International Institute of Earthquake Engineering and Seismology (IIEES), Tehran, Iran, email: behrokh@iiees.ac.ir

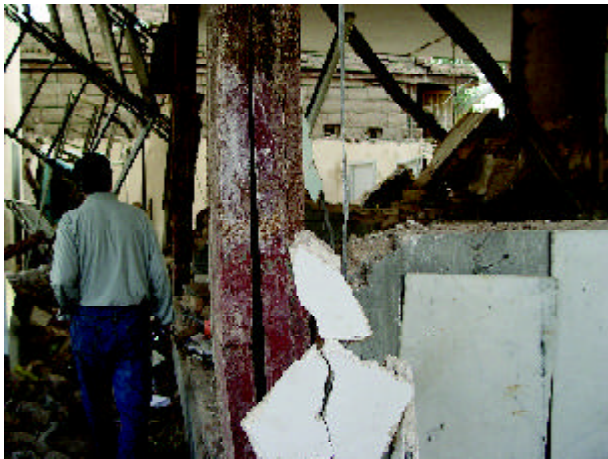
Different failure modes in steel buildings, including overall collapse and damage to or failure of structural components such as columns, braces and connections, were observed in Bam after the earthquake. The most common type of column used was the batten column. In some buildings, box columns were used and, with this type of column, failure modes such as rupture in the longitudinal joint, see Figure (1) and local buckling, see Figure (2) were observed.

Figure 1. Rupture of longitudinal joint in box column.

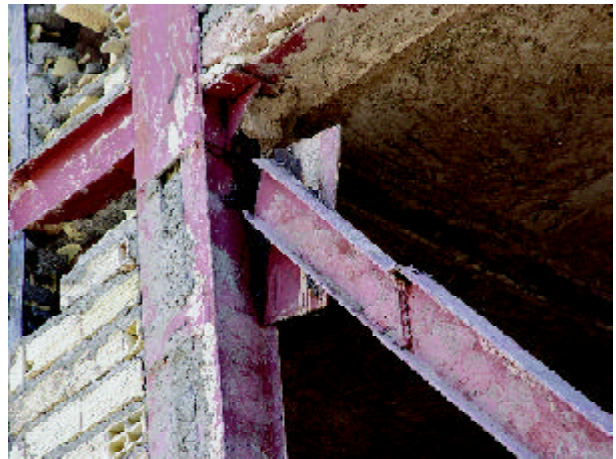
Figure 2. Local buckling of box column.

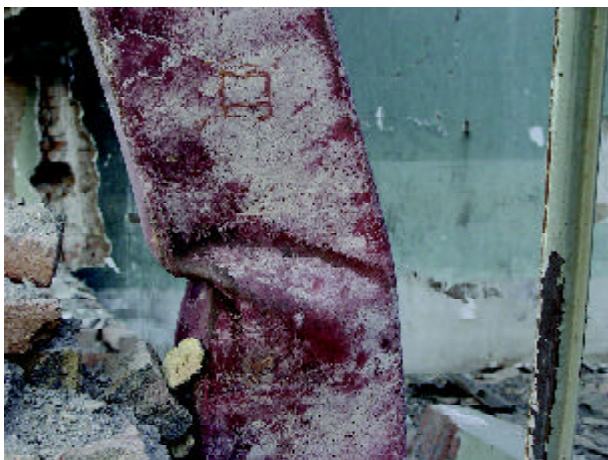
Figure 3. Rupture of connections in concentrically X bracing.

common type of bracing in steel braced frames in Bam. The observed failure modes in these braces were out of plane buckling and rupture of connections. The major reasons for these failures were construction defects and incomplete welding of connections. Some examples of bracing failures are shown in Figures (3) and (4).

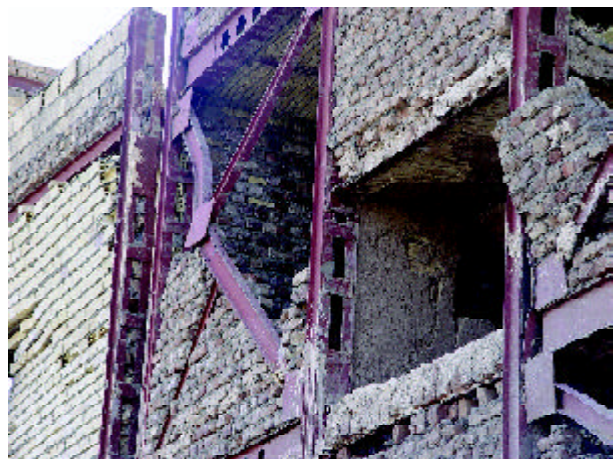
Figure 4. Out of plane buckling of concentrically X bracing.

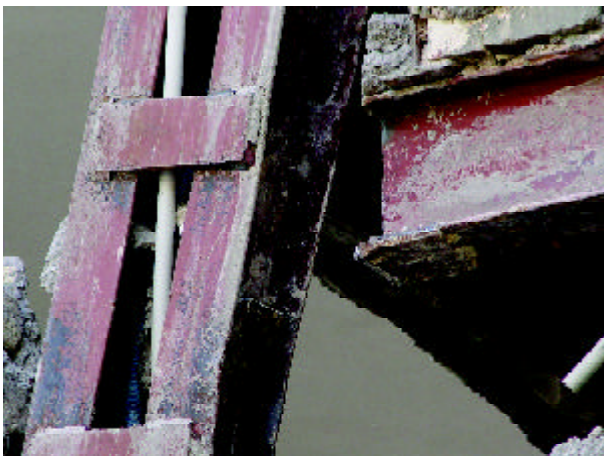
Beam to column connections in most steel buildings in Bam are khorjini and simple connections with top and bottom angles. Weld fractures, rupture of connection devices and rupture of connection plates from batten columns were failure modes observed in these connections. Some examples of these failures are shown in Figures (5) to (7). Because of the wide range of failures in connections, one can concluded that the collapse of structures was mostly initiated by connection failures. Failure modes in steel structures such as were seen in Bam have been reported in most earthquakes [1-8].

**Figure 6.** Rupture of seat angle of simple connection.

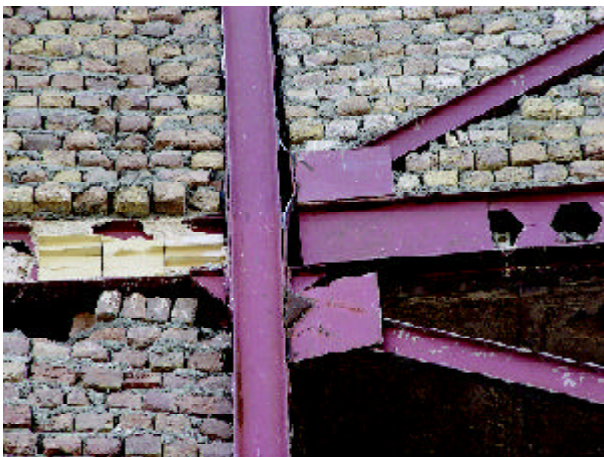
**Figure 7.** Separation of connection plate of batten column.

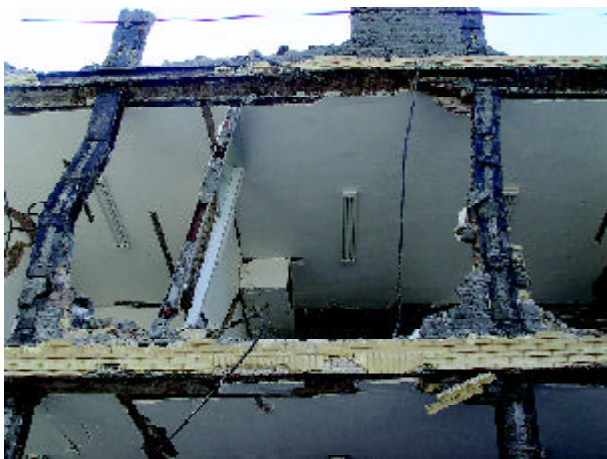
The overall buckling of batten columns was observed in some steel buildings in Bam. An example of overall buckling in the columns of a pharmacy is shown in Figure (8). It is significant that the buckling has occurred about the hollow axis. As mentioned earlier, according to the code, this type of buckling

**Figure 8.** Overall buckling of batten columns about hollow axis in a pharmacy.

is undesirable. The other important point revealed in Figure (8) is the occurrence of buckling in the top story of the building, in which columns have low gravity loads. This may be due to the increased column axial force through the effect of the high vertical component of the earthquake. Reyas-Salazar et al [13] studied the effect of vertical acceleration on the seismic response of steel frames with flexible connections. Another example of overall buckling of the batten column about the hollow is shown in Figure (9).

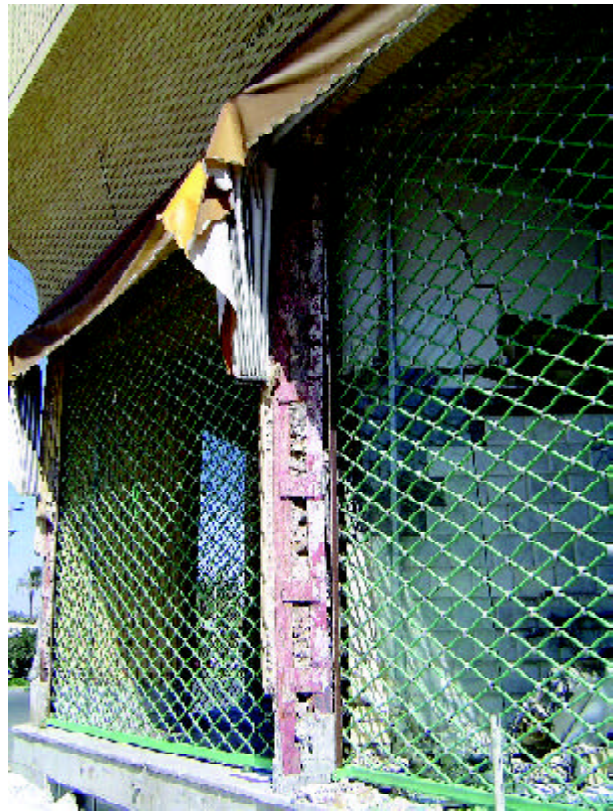
**Figure 9.** Overall buckling of batten columns about hollow axis in a store.

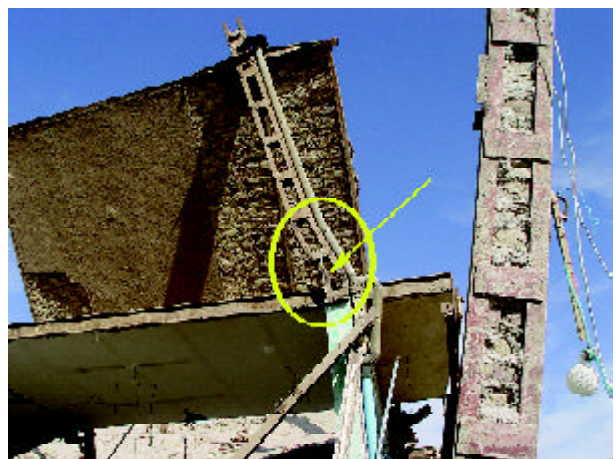
An example of local buckling in one of the chords of a batten column is shown in Figure (10). Because of the relative direction of batten columns and khorjini connections, in spite of code recommendations, a bending moment about the hollow axis could be applied to batten columns. This bending moment, as mentioned before, may lead to the occurrence of local buckling in batten columns, as shown in Figure (10).

**Figure 10.** Local buckling of one chord of batten column.

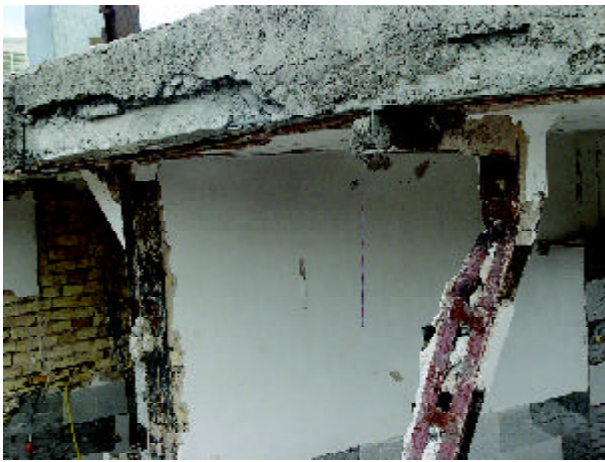
Lateral-torsional buckling is a probable mode of failure in batten columns. Nevertheless, there is no special provision regarding lateral-torsional buckling of batten columns in the part 10 of the *INBC*. In some cases, lateral-torsional buckling was observed in batten columns in Bam. An example of this mode of failure is shown in Figure (11).

Figure 11. Lateral-torsional buckling of batten column in a store building.

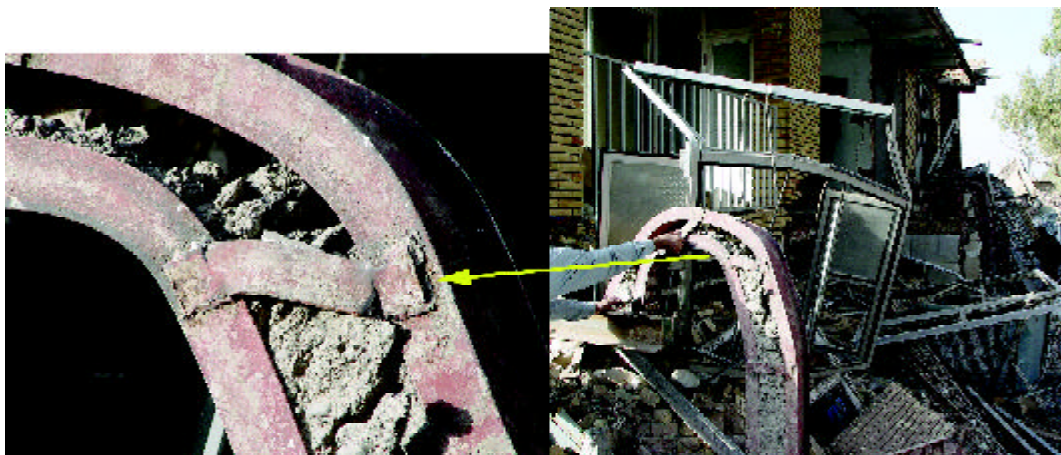
Some examples of rupture in battens are shown in Figures (12) to (14). In Figure (12), the dimension of battens are smaller than those that are common in steel buildings. The rupture of these battens could occur due to incorrect design and construction, or usage of improper materials.

Figure 12. Rupture of battens in a two story residential building.

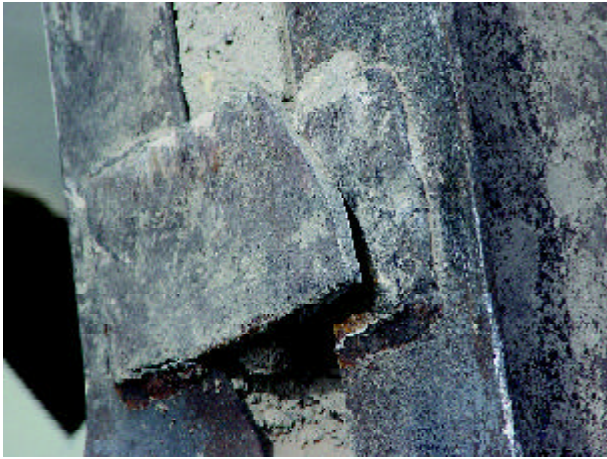
In Figures (13) and (14), battens having proper dimensions are observed. The rupture of these battens may be due to the increase of applied forces on battens relative to design forces in the codes. As mentioned, an increase of applied forces may result in the application of bending moment about the hollow axis or the occurrence of large deformations in columns. Such failures in battens are undesirable and must be prevented. It is evident that further study into the design forces of battens is required.

Figure13. Rupture of battens in a pharmacy.

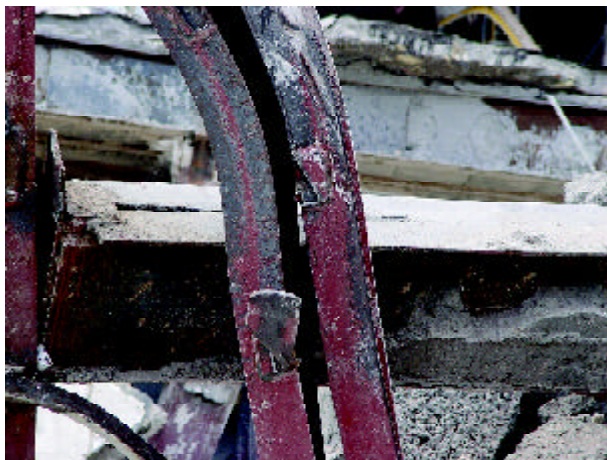
Figure 14. Rupture of battens in a shopping center.

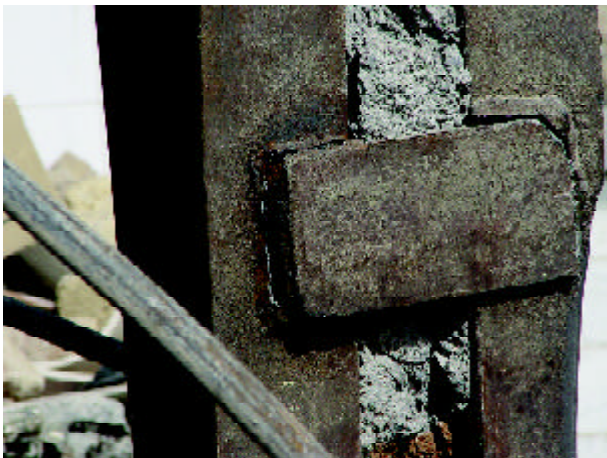
In many cases, the failure of battens in batten columns occurs in the weld of the battens to chords. Some examples of weld ruptures are shown in Figures (15) to (17). Because of the absence of quality

control for welding in Iran, the occurrence of weld failures in different components of steel buildings during earthquakes is expected. However, batten rupture may also lead to the rupture of batten welds. In the

Figure15. Weld rupture in battens of batten column in a pharmacy.

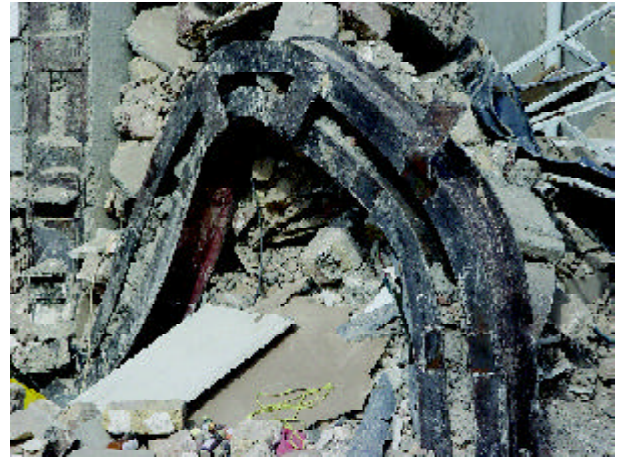
column shown in Figure (16), all of the battens failed at the welds. This failure may have led to separation of the chords and the collapse of the batten column.

Figure 16. Weld rupture in all battens of batten column in a pharmacy

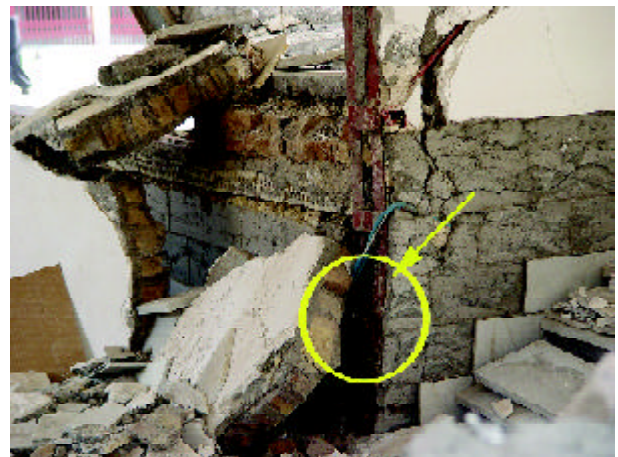
Figure17. Weld rupture in battens of batten column in an insurance building

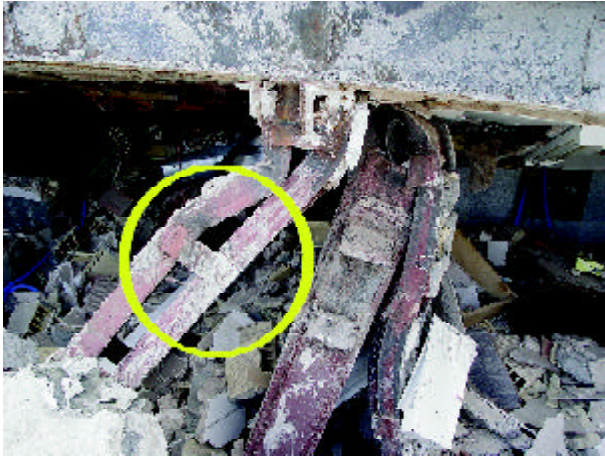
Plastic shear deformation of battens in batten columns increases the influence of shear in the capacity of batten column and also leads to a decrease in the distance between the chords, which may cause a decrease in the axial capacity of the batten column. An example of plastic shear deformation of battens is shown in Figure (18).

Figure18. Plastic shear deformation of batten of battens.

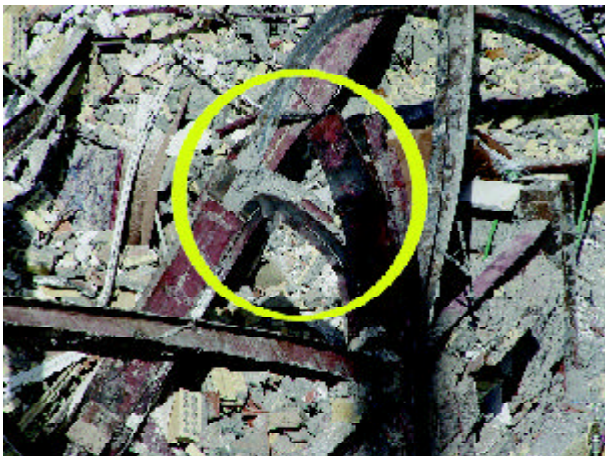
splices in columns must be scrupulous. An example of splice failure of a batten column is shown in Figure (19).

Figure19. Failure of batten column in splice location in kimia building.
