Lessons Learned from Steel Braced Buildings Damaged by the Bam Earthquake of 26 December 2003

Keywords: Bam earthquake; Steel buildings; Welded bracing connections; Brittle failure

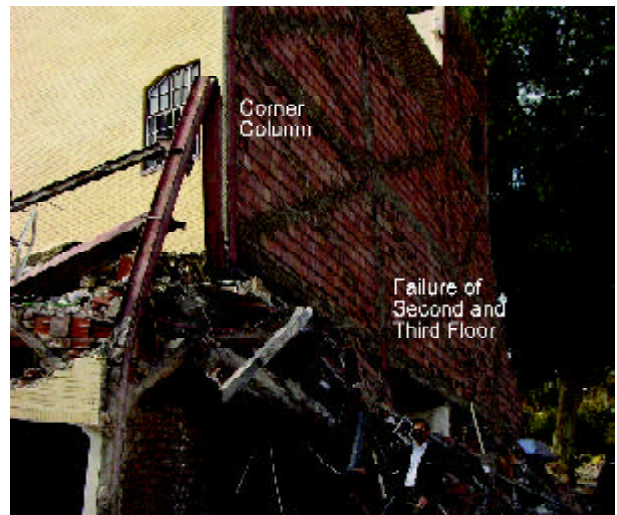
Figure 3. Northern view of Kimia building.

Northern and southern views of this five story residential steel braced building is shown in Figures (3) and (4). The lateral load resisting system of this

building was diagonal bracing in the East-West direction and a simple frame in the North-South direction. As shown in these Figures, the bracings in the second and third stories fractured and a lateral movement of about 400 cm, occurred in these stories. The remaining fourth and fifth stories collapsed in aftershocks. Failure of the slender rod braces ($\varnothing 18$) with very weak connections shown in Figures (5) and (6) led to a dramatic reduction in the lateral strength and stiffness of the building in second and third stories.

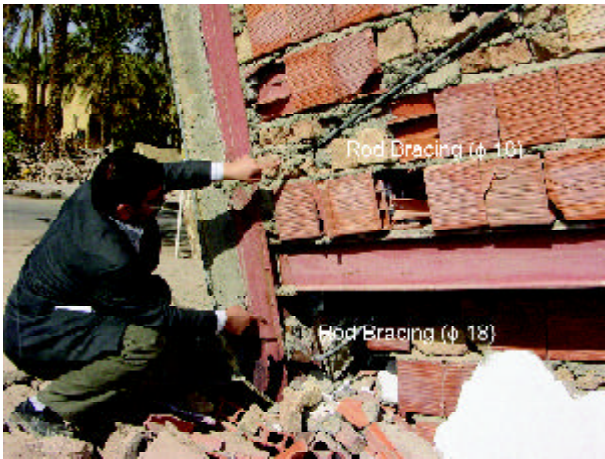
Figure 5. Rod bracings in stories.

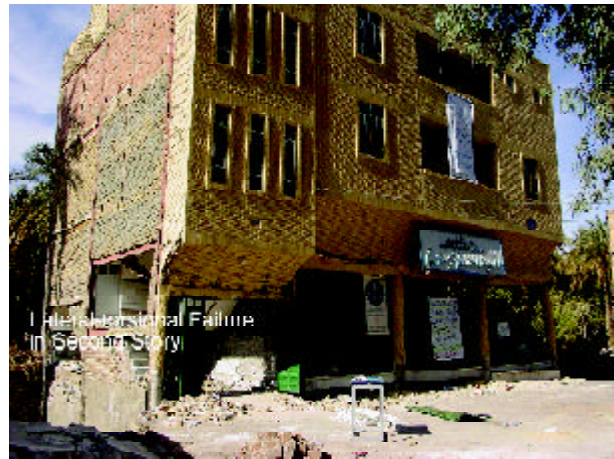
Figure 7. Eastern view of the insurance building.

Eastern and northern views of this four story braced building are shown in Figures (7) and (8). For architectural considerations, cross bracing of this building on the Eastern side (on the street) and also in

the second story was not considered. This resulted in horizontal and vertical irregularities. Weak cross bracings and very poor welded braced connections caused a sudden change in stiffness and strength of this story. Therefore, excessive lateral-torsional deformations of about 50cm occurred in the corner column of the second story. It should be mentioned that the height of this story was greater than for the other stories. This is a common problem occurrence in buildings with shops in the ground floor. No damage occurred in the basement, surrounded by brick masonry infill walls.

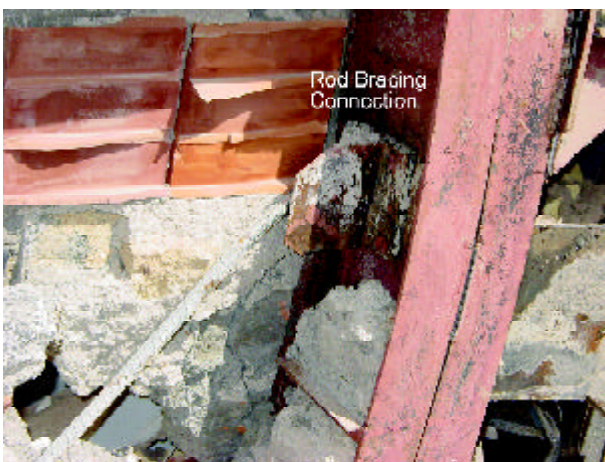
Figure 6. Rod bracing connections.

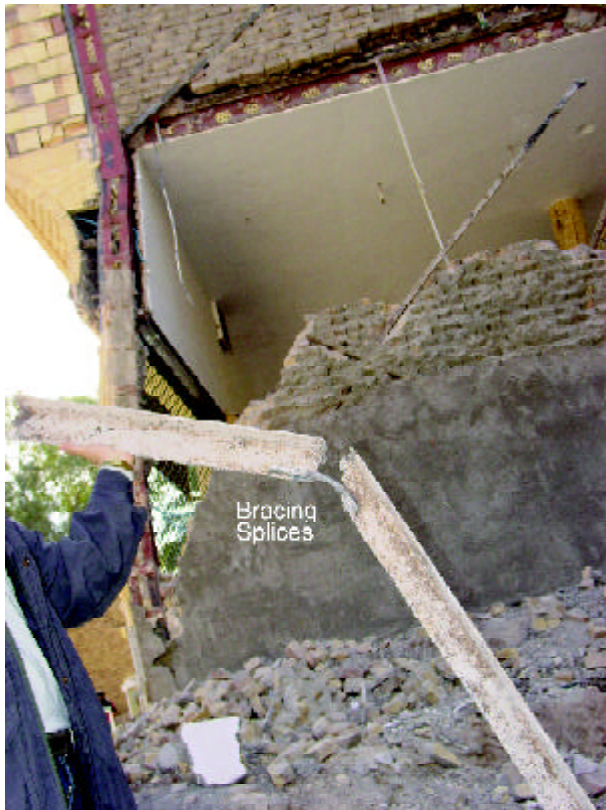
A typical cross bracing member of this building (L80x80x8) spliced with a rod ($\text{Ø}16$) is shown in Figure (9). However, the failure occurred in bracing connection, not in the spliced section. In other words this kind of weak splice was stronger than the bracing connections. The masonry infill brick walls of the first story prevented the total collapse of this building. Because of excessive deformation and damage that

Figure 9. Brace spliced with a rod.

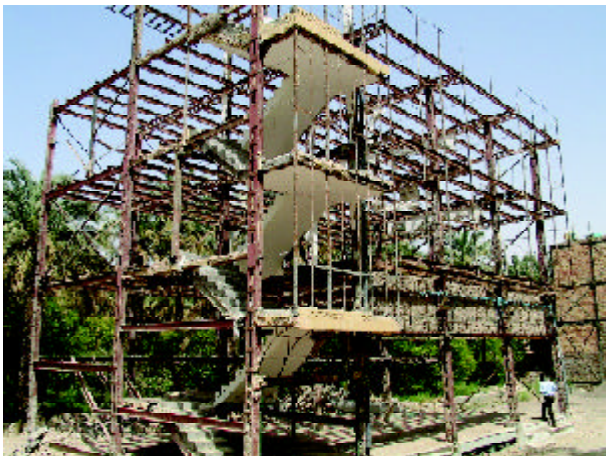
occurred in the second story, the owner decided to demolish and reconstruct this building (Figure (10)).

Figure 10. Demolition of the insurance building.

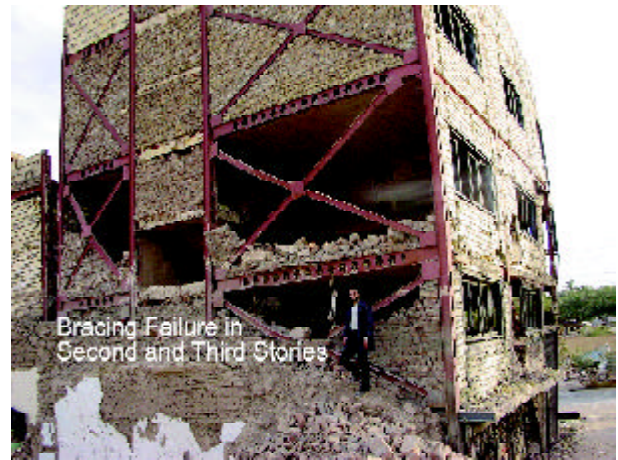
Figure 11. North view of the residential building.

The Northern view of this four story braced building is shown in Figure (11). Cross bracings in the second and third stories of this building failed during the earthquake. Lateral deformations of about 40cm occurred in the second and third stories. Fracture of tension brace member connections and buckling of compression members were the main modes of failure as shown in Figures (12) and (13). Fracture of connection plates between columns and gusset plates was another type of failure (Figure (14)).

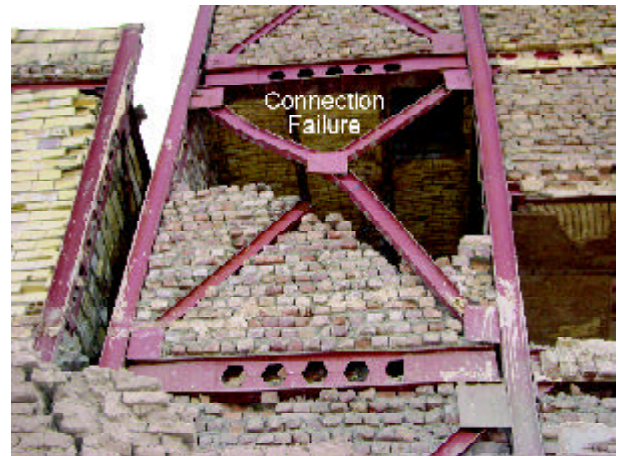
Figure 12. Fracture of bracing connections.

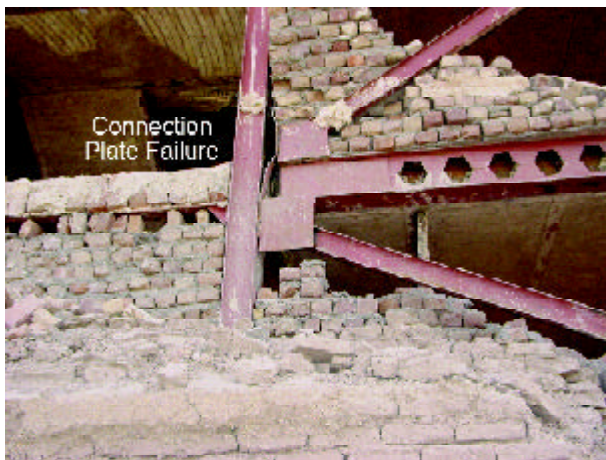
Figure 14. Fracture of bracing-to-frame connections.

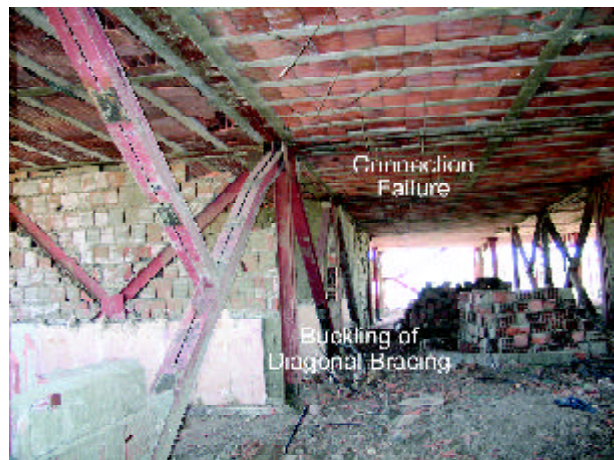
Failure of cross bracing connections in the first story is shown in Figure (16). Excessive damage of bracing members is caused by the impact of compression bracing after connection failure. A compression buckling of diagonal bracings of the first story is shown in Figure (17). Built up cross sections similar to columns were used as diagonal

Figure 17. Buckling of diagonal bracings.

4. Flexural strength: *AISC* requirements stipulate that the design flexural strength of the connections shall be equal to or greater than the expected nominal flexural strength $1.1 R_y M_p$ of the brace about the critical buckling axes. This requirement is not included in the Iranian code. An example of connection failure due to bracing buckling has been observed in sample buildings as shown in Figure (17).

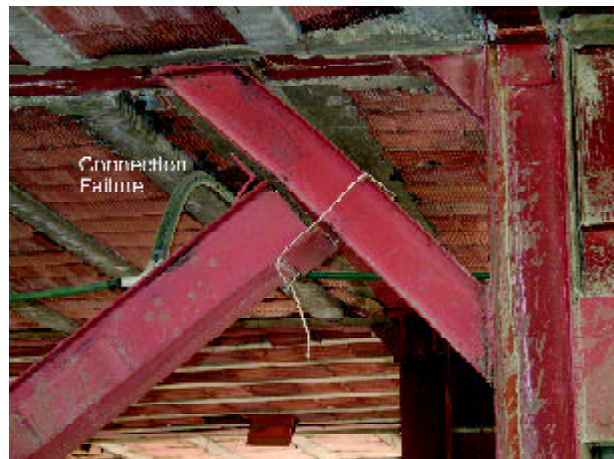
bracings. Another type of failure in the cross bracing connections to the frame system is shown in Figure (18). This kind of connection was considered in some cross bracings that lacked sufficient length.

Figure 18. Failure of bracing connections to frame.

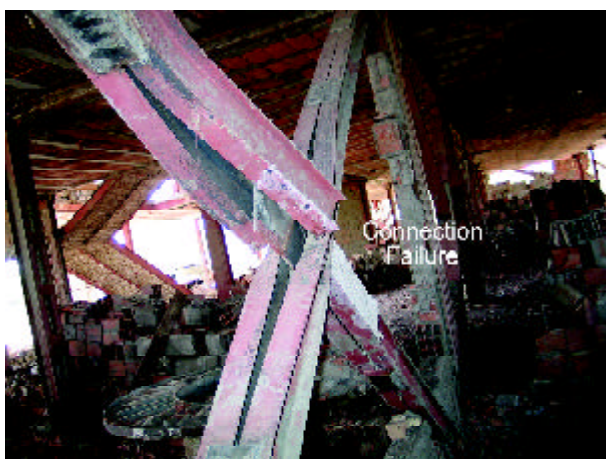
Figure 16. Failure of cross bracing connections.

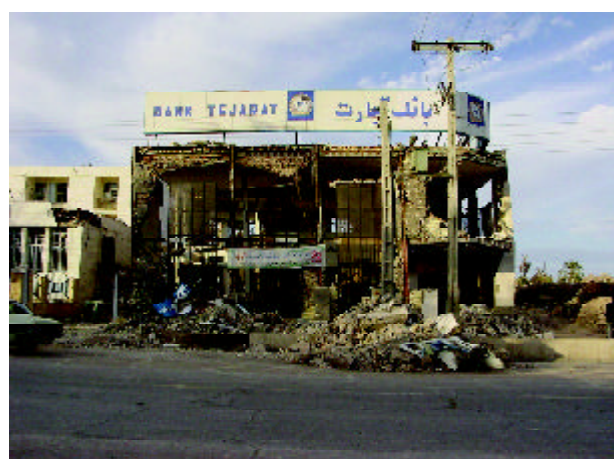
Figure 19. Southern view of bank Tejarat.

The Southern view of this two-story braced building is shown in Figure (19). Very poor braced connections and braced member splices caused heavy damage.

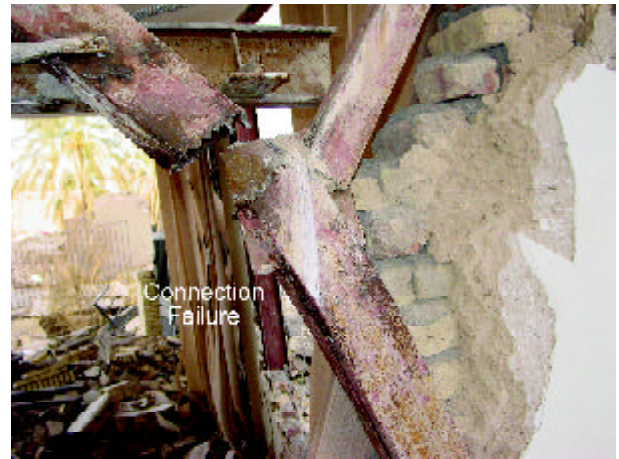
An example of bracing member fracture in a poor spliced section is shown in Figure (20). The small dimensions of the gusset plate, and poor quality and insufficient welding are clear in Figures (21) and (22).

Figure 22. Fracture of bracing connections.

As shown, extremely bad detailing has been used in the bracing connections of this building. It should be mentioned that all bank buildings were heavily damaged during the earthquake.

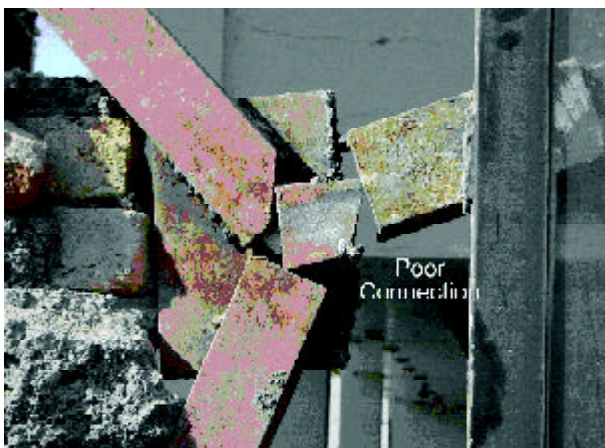
Figure 21. Very poor bracing connections.

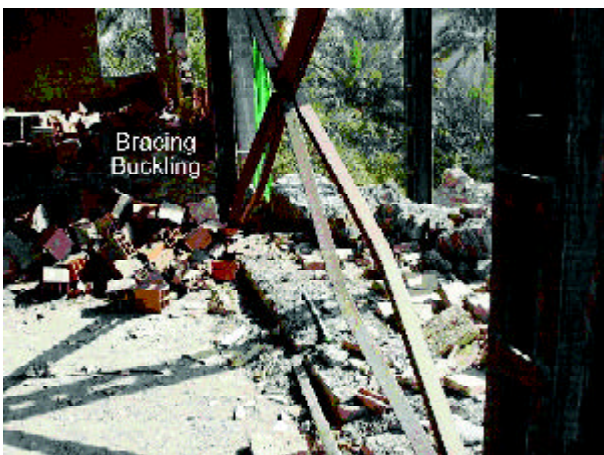
It should be noted that for out-of-plane buckling in bracing members, failure of infill walls is inevitable. An example of this type of buckling in built-up braced members and failure of the infill walls is shown in Figure (26). As can be seen, no stitches have been used in the bracing members and out of plane buckling occurred in individual elements.

Figure 26. Out of plane buckling of built up bracing.

3. Built-up members: Based on the Iranian code requirements, the spacing of stitches shall be such that the slenderness ratio (l/r) of individual elements between the stitches does not exceed 0.7 times the governing slenderness ratio of the built-up members. Generally, this requirement was not observed in built-up bracing members. An example of this kind of bulking is shown in Figure (26).
