# The Behavior of Special Structures During the Bam Earthquake of 26 December 2003

Sassan Eshghi and Mehran Seyed Razzaghi

Structural Engineering Research Center, International Institute of Earthquake Engineering and Seismology (IIEES), Tehran, Iran, email: s.eshghi@iiees.ac.ir

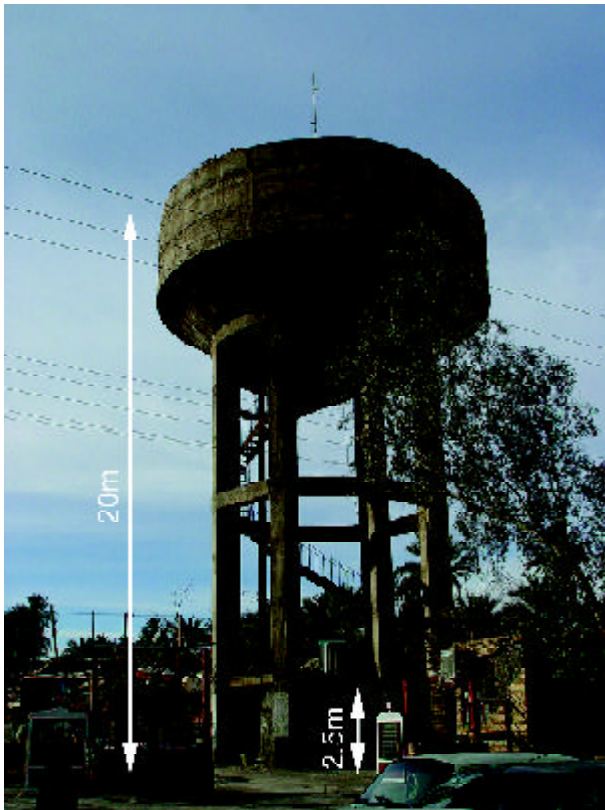
Fire Station. The tank was designed and constructed about 32 years before the seismic event and earthquake induced loads were not taken into account during the design process. A tower with six rectangular columns supported the tank with the columns joined with rectangular beams at different elevations. Brick infill walls approximately 2.5m in height were constructed between tower columns to make an office beneath the tank, see Figure (3). The tank was nearly empty at the time of the earthquake.

Figure 3. General view of the Bam elevated RC tank.

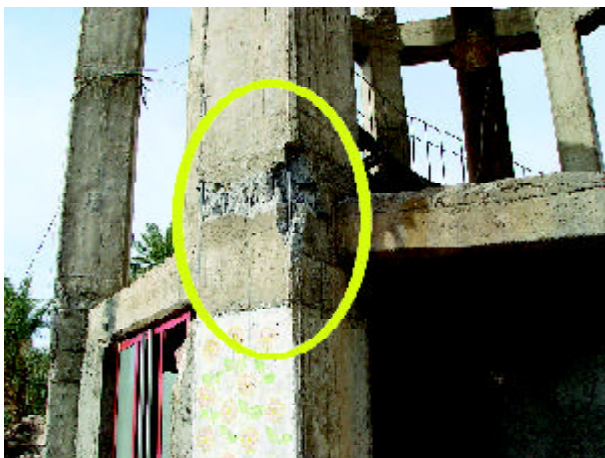
The response of RC elevated water tanks in past earthquakes shows that beam-to-column joints in these types of structure are susceptible to ground shaking [4]. Following the Bam earthquake, the RC tower of the aforementioned tank cracked, but did not collapse.

Inaccurate detailing was the major reason for the tank damage. As shown in Figure (4), the concrete column cracked near the beam-to-column connection and the longitudinal reinforcing bars buckled at that position. The main reason for this type of damage was the lack of transverse bars on the critical length of the column near the beam-to-column connection, which has a high potential for plastic hinge formation. Although, according to the Iranian concrete code (ABA) [5], the maximum allowable spacing between stirrups is 250mm, the spacing between transverse stirrups in the tower RC columns was much greater. Another failure mode of the tower was damage to beams adjacent to the column joint, in which the crack penetrated to the column, see Figure (5).

Figure 4. Inaccurately detailed cracked RC column [1].

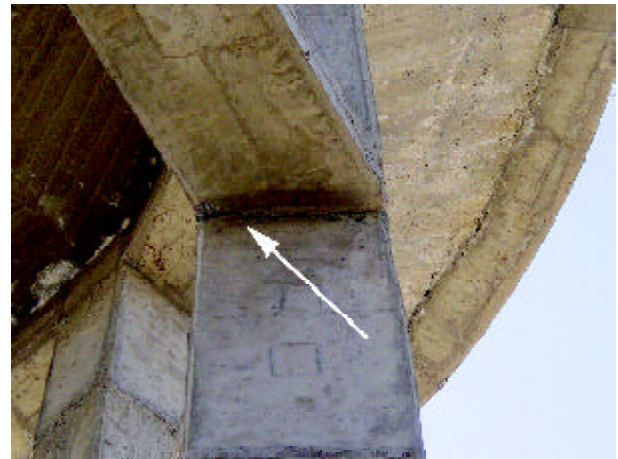
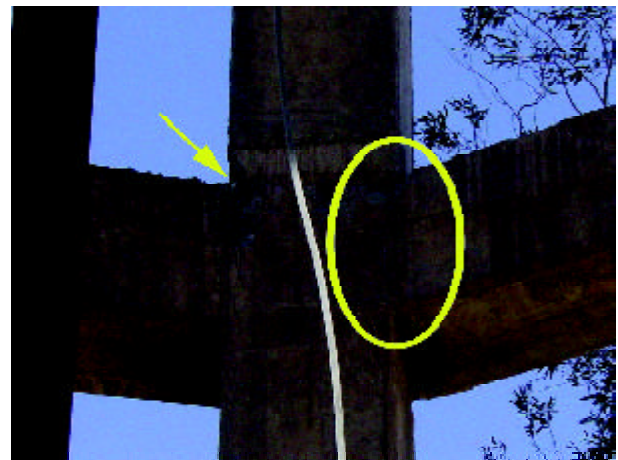
Figure 5. Damage to beam next to column joint.

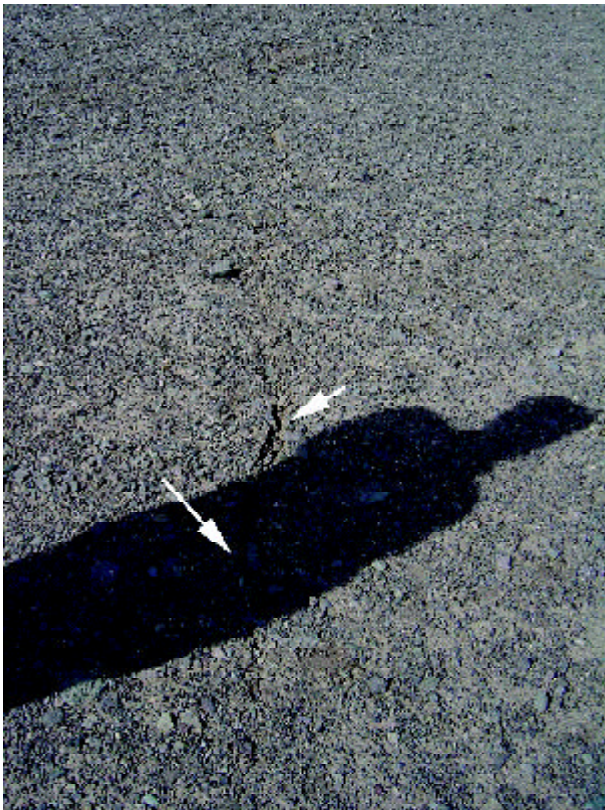
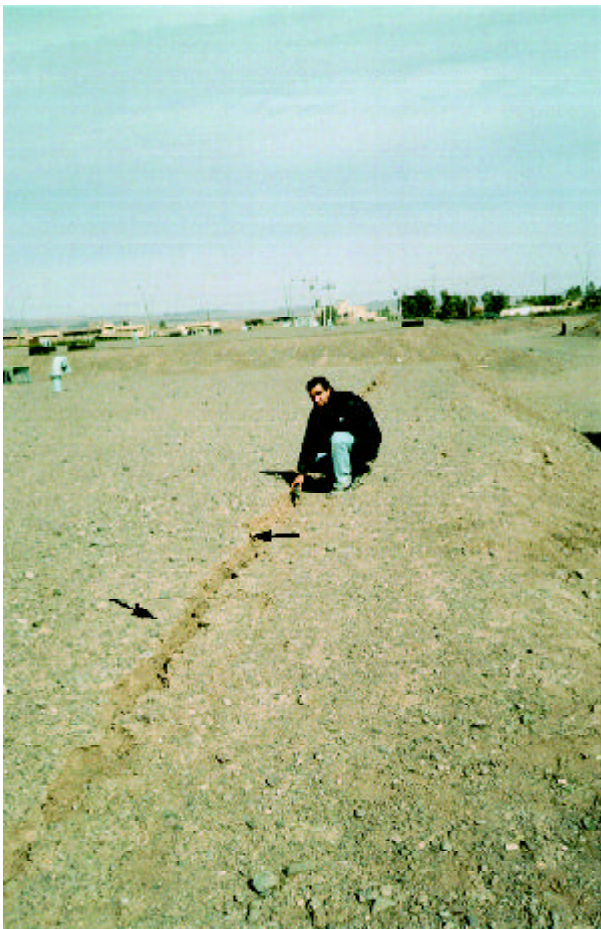
damage. Soil settlement of about 10cm took place in the earth fill of each tank and tensile cracks were observed at the top of the earth fill, see Figure (6). None of the buildings in the plant suffered serious damage and the plant was operable after the earthquake.

**Figure 6.** Settlement and tensile cracks observed in tank earth fill.

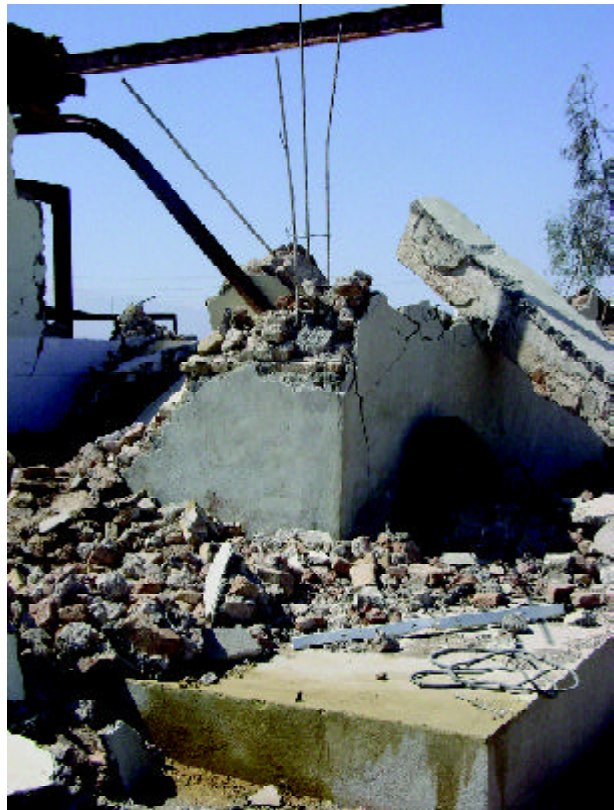
The Baravat water treatment plant is constructed over the Bam fault. There were two underground water tanks at this plant. Both tanks are stone masonry. Before the seismic event, both tanks worked at full capacity, but the plant suffered major damage to tanks and annex structures during the earthquake and was forced to shut down. All of the annex buildings, including the chlorination building, collapsed completely, see Figure (7). These structures were un-reinforced brick masonry buildings. Leakage from the tank wall and bottom occurred after the earthquake and cracks were also found at construction joints on the masonry retaining walls surrounding the tank, see Figures (8) and (9).

**Figure 7.** Collapse of chlorination building.

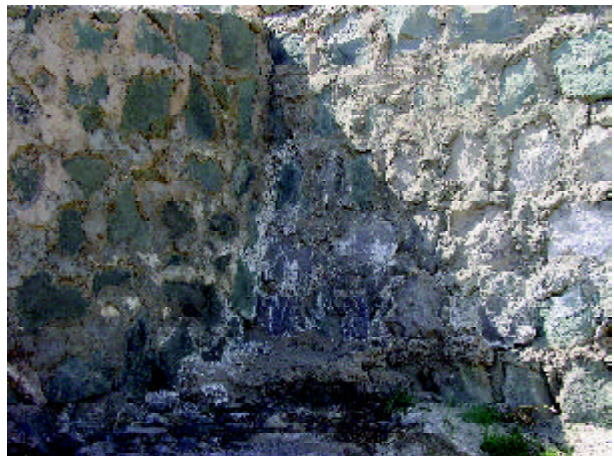
**Figure 8.** Leakage of water from tank wall.

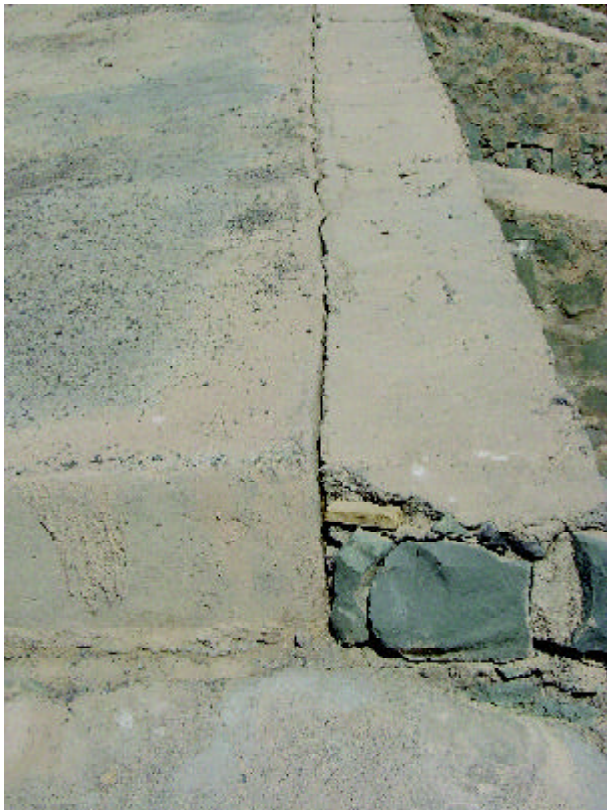
**Figure 9.** Cracks observed at construction joints of surrounding wall

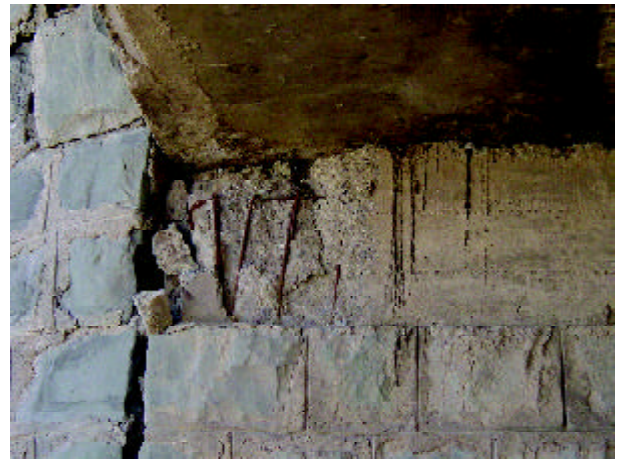
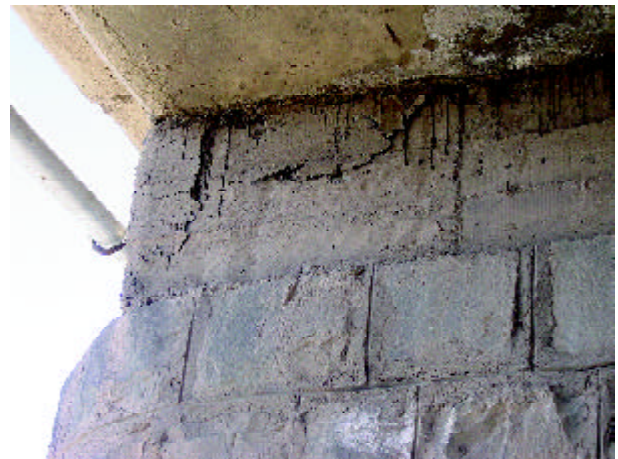
In general, bridges sustained little or no damage. The most affected bridge, Espikan Bridge north of Bam near Arg-e Bam, sustained little damage. Espikan Bridge is a uniform bridge with an RC deck and stone masonry columns and 14 spans across the Poshtrood River, see Figure (10). As shown in Figure (11), the RC bent caps of the bridge cracked with the longitudinal movement of the deck in the north-south direction. No visible damage occurred to

**Figure 11.** Damage to RC bent caps from deck movement.

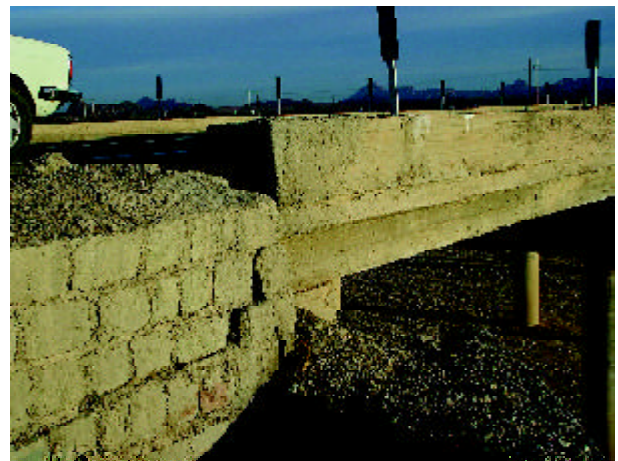
The Darzin Bridge also experienced longitudinal movement of the superstructure and the stone abutment cracked as a result of settlement of the abutment, see Figure (12). However, the bridge was still safe for use after the earthquake. No structural damage occurred to other observed bridges in the affected region.

**Figure 12.** Settlement of Darzin bridge abutment.

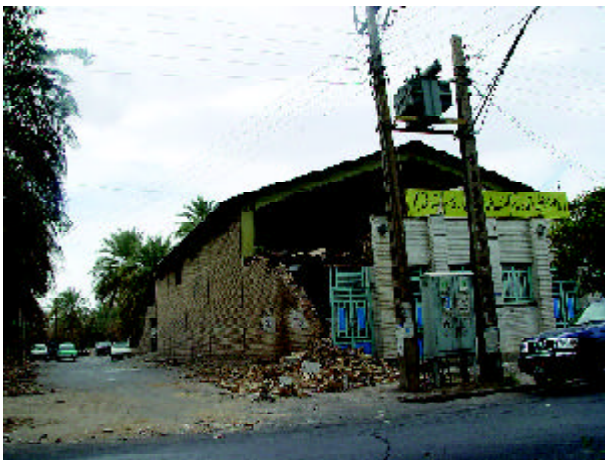
As shown in Figure (13), failure of annex buildings was a typical damage mode for industrial structures with annex buildings. Annex buildings are generally brick masonry low-rise buildings constructed with adjacent gable frames without joints. Failure of annex buildings was, in most cases, caused by torsion due to asymmetric distribution of resistant walls or pounding of an adjacent industrial structure.

Figure 13. Damage to annex building of an industrial frame [1].

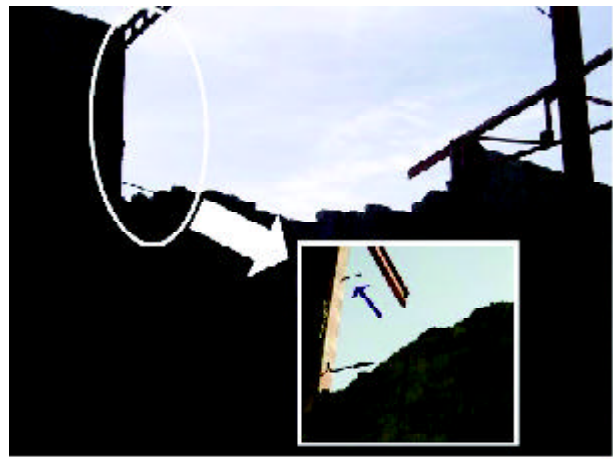
Failure of infill walls was the most common damage mode of industrial structures. The main reason for this mode of failure was lack of horizontal anchors and/or wall posts to restrain the infill walls to the structure. As indicated in Figure (14), inaccurate detailing of the anchor connections to the structure and lack of overlap length caused failure of infill walls.

Figure 14. Failure of infill walls due to inaccurate detailing of anchors [1].

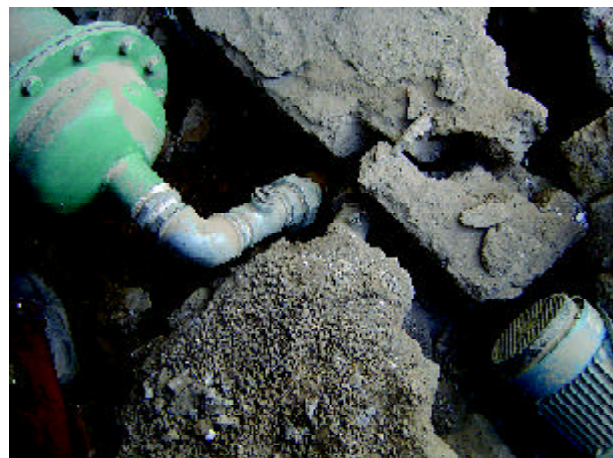
the collapse of mechanical buildings caused heavy damage such as the rupture of connected pipes and residual deformation of equipment components, see Figure (15). Damage to equipment resulted in the closure of industrial plants after the main earthquake.

Figure 15. Damage to equipment in the collapse of mechanical buildings [1].

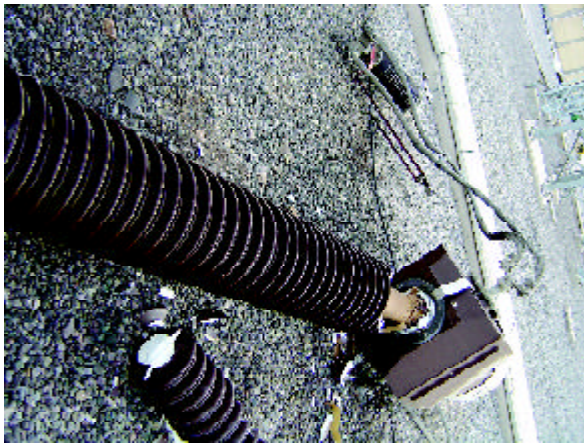
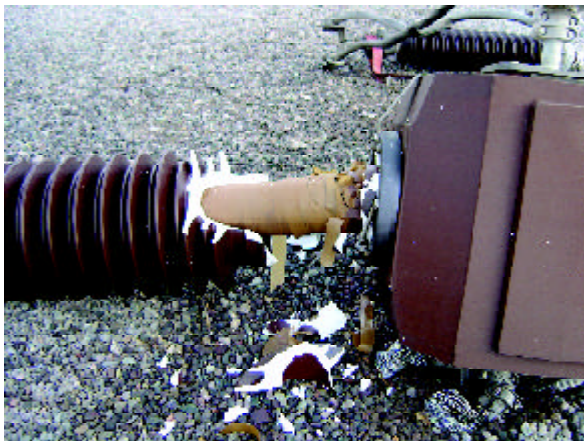
As mentioned before, the electrical substation was one of the critical facilities of the affected area. It is composed of two sections for 230kV and 132kV. The equipment in this station sustained heavy damage. In general the extent of damage in the 230kV section was greater for the 132kV section. More than 13 bushings in the 132kV section cracked and collapsed, see Figure (16). Both 132kV and 230kV transformers moved due to the sliding response of equipment. One 230kV transformer moved about 40cm from its original position. The movement of transformers caused the base rails to sustain plastic deformation. Figure (17) indicates the sliding response of the 230kV transformer to ground shaking.

**Figure 16.** Damage to bushings at Bam substation.

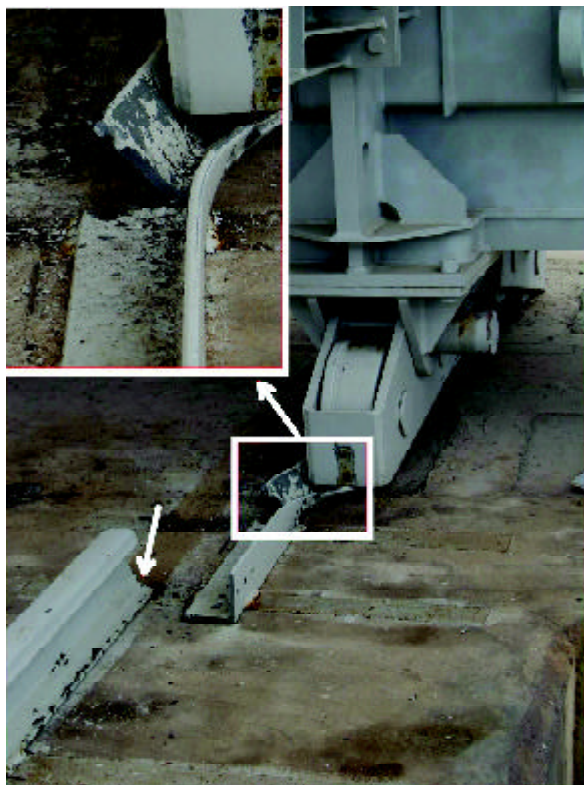
**Figure 17.** Displaced 230kV transformer [1].

As indicated in Figure (29), the peak ground acceleration required for the overturning of a transformer of  $\alpha = 25^\circ$  is 0.61g, which is less than the PGA of the Bam earthquake in the fault-normal direction. It seems that the existence of base rails and connections to the transformers was the main reason for the stability of the transformers in the Bam station.

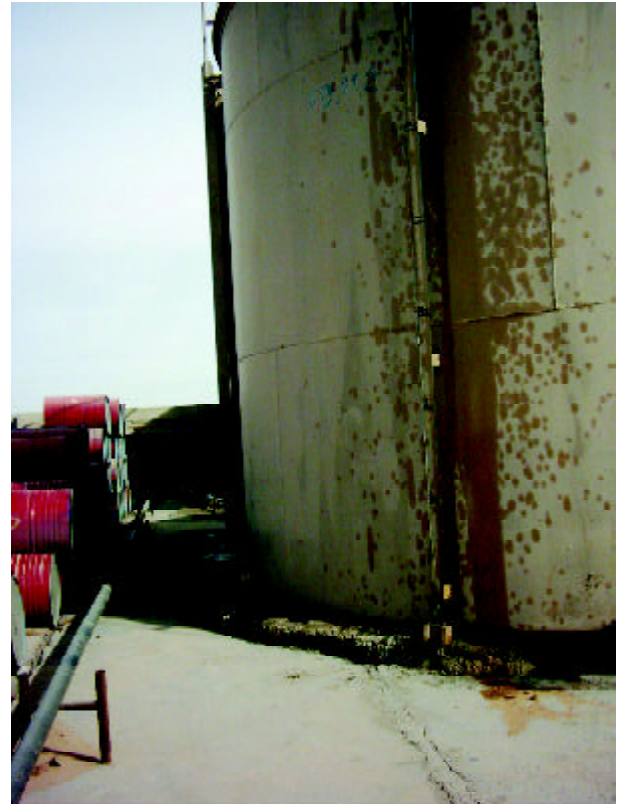
Three out of six on-grade steel oil tanks at Roghan Jonub Company (see part 3) experienced leakage of liquid from roof-to-wall junctions from sloshing during the quake. Other damage modes such as elephant foot buckling, rupture of rigid piping, and tank were not observed in these tanks. Figure (18) shows the leakage of oil from on-grade tanks.

**Figure 18.** Leakage of oil from tank due to sloshing [1].

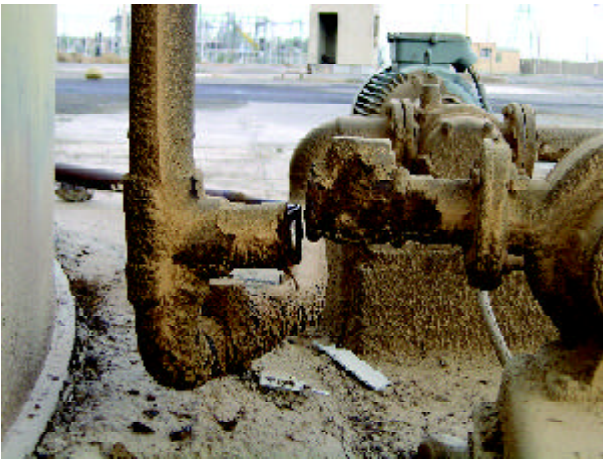
A cylindrical on-grade gasoline tank next to Bam electrical power station, which was nearly empty, suffered heavy damage. Rigid piping connected to the tank ruptured, probably from the inaccurate erection of the pipes, see Figure (19). The tank foundation was damaged due to tank uplift, but shell buckling did not occur, see Figure (20).

Figure 19. Rupture of pipe connections.

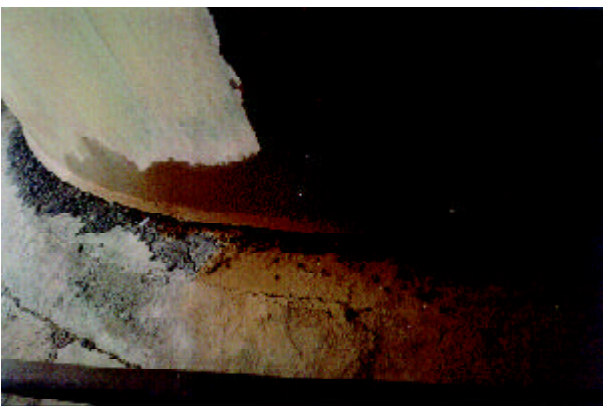
Figure 20. Damage to tank foundation due to tank uplift.

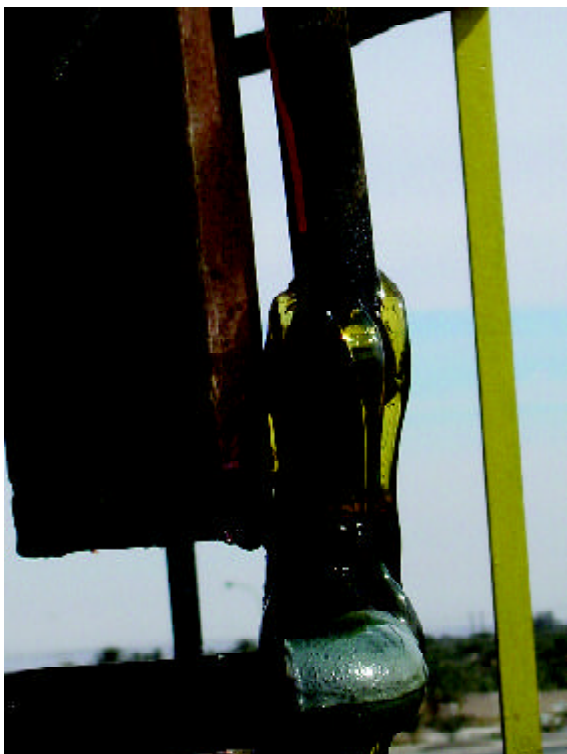
Elevated oil tanks at the Roghan Jonub plant were severely damaged and failed to contain the oil because of the failure of piping connections, see Figure (21). Also, as shown in Figure (22), a tank tower column punched the tank shell.

Figure 21. Leakage of oil due to rupture of pipes [1].

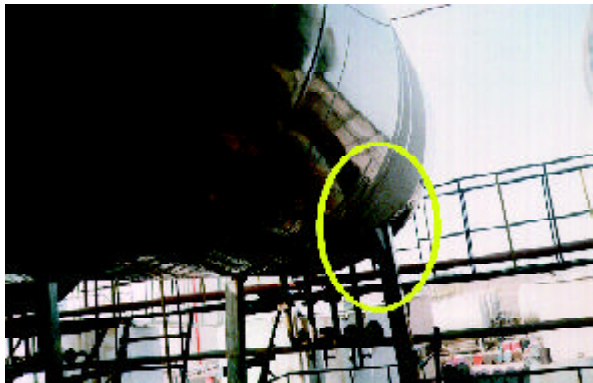
Figure 22. Punching of tank shell [1].

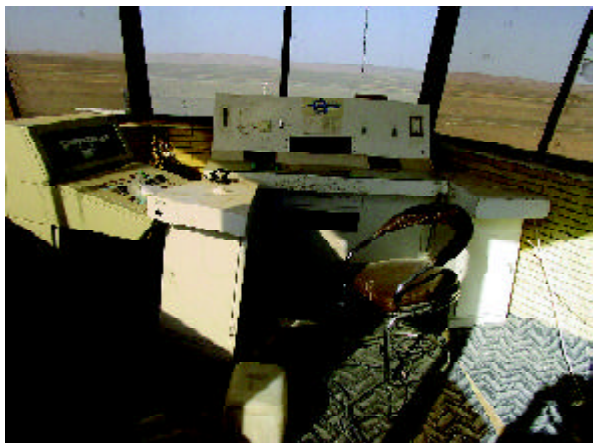
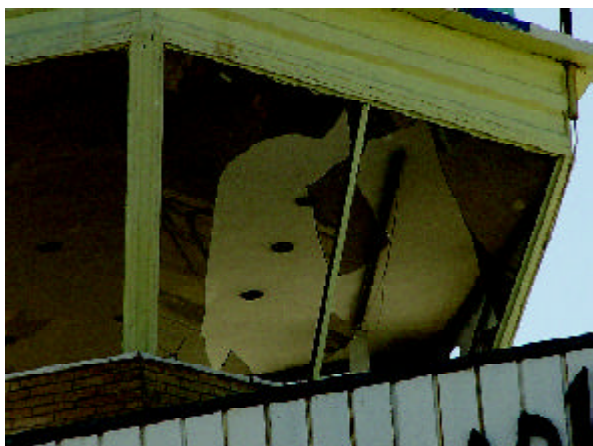
Bam Airport is located north of Bam between Baravat and Arg-e-Jadid. The control tower of the airport was closed because of heavy non-structural damage, see Figure (23). Since no structural member suffered serious damage the airport brought back to full operation with the use of a portable control unit. Non-structural components also suffered heavy

Figure 23. Damage to airport control tower.

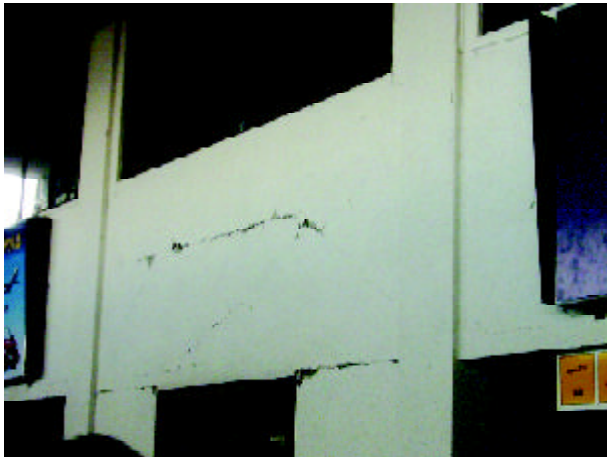
Most masonry infill walls at the airport cracked, Figure (24). Some false ceiling panels concealing power cables and such fell. No structural damage occurred due to the pounding of adjacent blocks, but finishing surfaces cracked or fell off at construction joints. The facade bricks of the terminal building fell off and damaged equipment and air conditioners, see Figure (25).

Figure 24. Damage to masonry infill walls at airport.

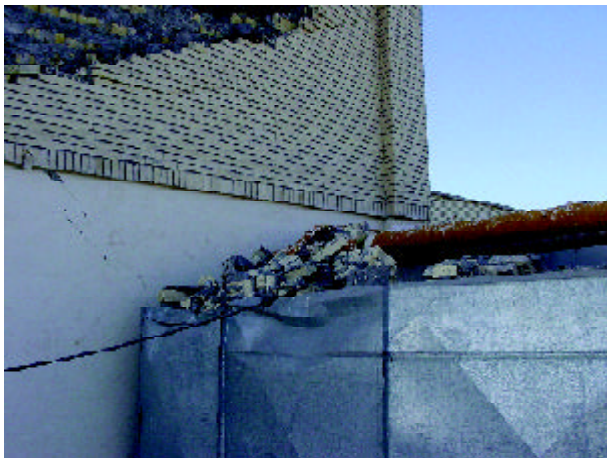
Figure 25. Damage to air conditioners.

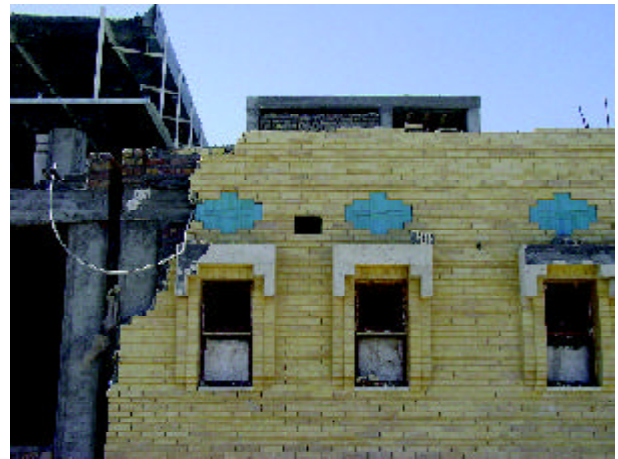
The Bam train station is under construction at a site south of Bam city. The structural system of the main terminal is a moment resisting RC frame with light-weight space trusses for the ceiling. Infill walls in the main building were cracked and facades were damaged from the strong ground motion, see Figure (26). Figure (27) shows shear cracks that occurred at some beam-to-column connections in the one-story RC frames.

Figure 26. Damage to façade at the Bam train station.

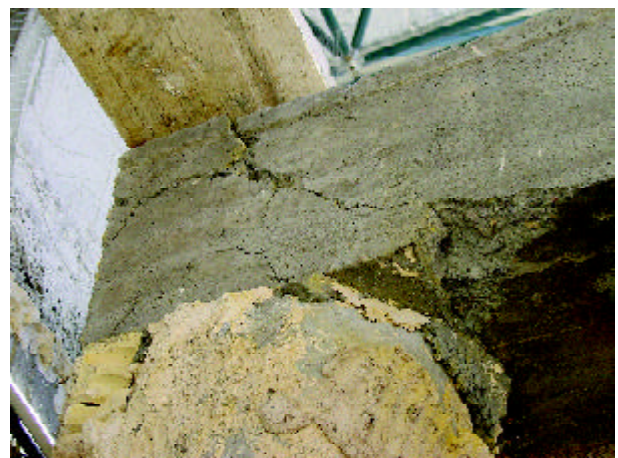
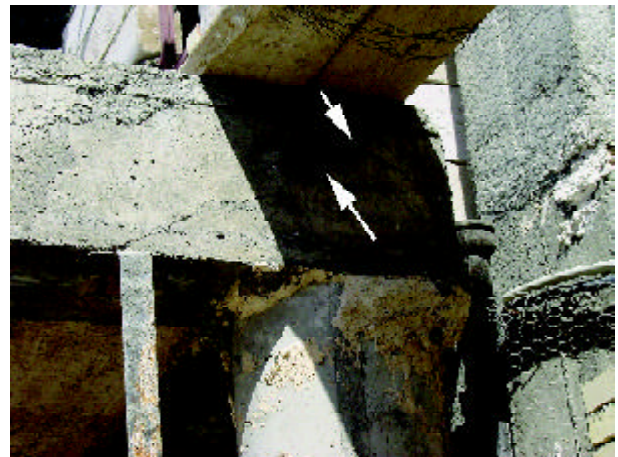
Figure 27. Shear cracks observed on beam-to-column joints at train station.
