Reconnaissance Report on Building Damage Due to Bam Earthquake of 26 December 2003

Yasushi Sanada¹, Masaki Maeda², Ali Niousha³, and M. Reza Ghayamghamian⁴

ABSTRACT: *The post earthquake investigations of the 26 December 2003 Bam-Iran earthquake were conducted by the Joint Reconnaissance Team of the Architectural Institute of Japan (AIJ), the Japan Society for Civil Engineers (JSCE), the Japan Association for Earthquake Engineering (JAEE) and the Ministry of Education, Culture, Sports, Science and Technology (MEXT) in collaboration with the International Institute of Earthquake Engineering and Seismology (IIEES). This paper reports the results of the AIJ team on damage evaluation of the buildings around the Bam strong motion station operated by the Building and Housing Research Center (BHRC). The seismic capacity of damaged buildings was approximately estimated. The results show that many residential houses in the investigated area were seismically vulnerable structures such as adobe and simple masonry structures. Poor construction quality was also found in some of the investigated buildings designed according to the current Iranian seismic code. Moreover, good correlation betwee

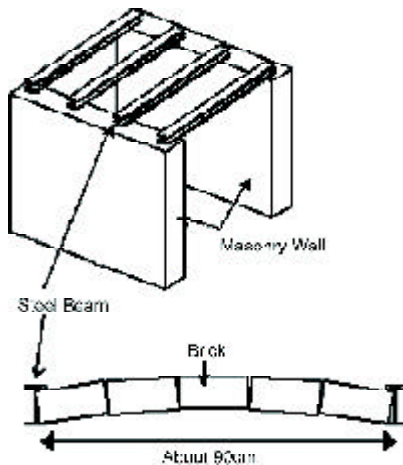
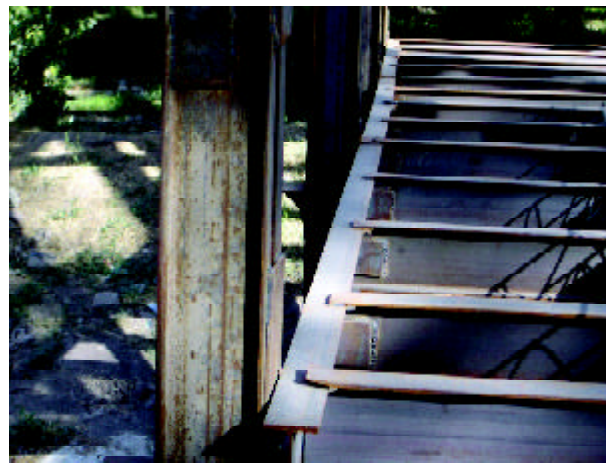
Figure 1. Commonly used jack arch slab (left: wall supporting, right: girder supporting).

The common slab in the buildings was the brick jack arch type, see Figure (1). The system consists of parallel I-shape steel beams at about 90cm distance. These beams support the brick arches, which are covered and leveled off by gypsum plaster in the bottom and mortar and tiling at the top.

These slabs are heavy and behave as a flexible diaphragm unless detailing is considered. The slabs constructed in this way are usually not tied together and to the supporting walls or girders. Therefore these kinds of slabs have caused heavy building failures and an unusually high death toll in many recent earthquakes in Iran.

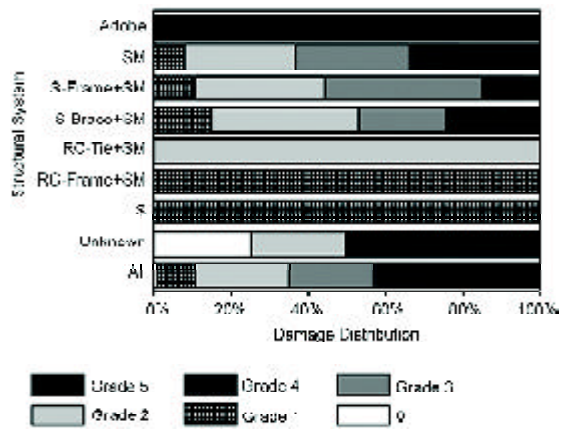
Figure 5. Damage distribution of each structural system.

Figure (5) shows the damage distribution of each structural system. All Adobe buildings were classified into Grade 4 and Grade 5. The sum of the ratio of Grade 4 and Grade 5 in *SM* buildings exceeded 30%, which was much smaller than the Adobe buildings. The damage ratios of *S-frame+SM* and *S-brace+SM* buildings were considered to be much less than that of the *SM* buildings, however, there were no big differences among them. This was caused by brittle fracture of poor welded connections in a few *S-frame+SM* and *S-brace+SM* buildings. On the other hand, the damages of *RC-tie+SM* and *RC-frame+SM*

buildings were quite slight because the connections in these buildings were constructed monolithically with other elements. These results, however, were derived from the only case in each system. The damage level of the only *S* building, which was the gymnasium structure, was Grade 1.

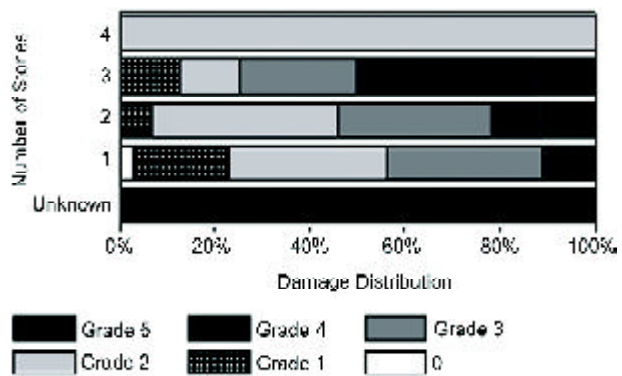
Figure 6. Effect of number of stories on damage distributions.

Subsequently, the relationships between the damage level and the number of stories, the construction age, and the location were investigated, however, adobe buildings were excluded from the data in order to prevent affecting the statistics. The effect of number of stories on damage distributions is investigated in Figure (6). The ratios of Grade 5 and Grade 4 were larger in case of higher buildings except the only four-story building case. Figure (7) shows the damage distributions before the establishment of National Standard code No. 2800 in 1987, from 1987 to the revision in 1999, and after 1999. No big differences were observed among these distributions; however, these results were derived from about half buildings except the unknown ones. This was caused by the technical and social backgrounds in Iran. These results revealed that the

seismic performances of Iranian buildings were strongly affected by partial weak points, in especial the jack arch slab and poor welded connections, and that the seismic code might be not spread in the local areas. In order to investigate the effects of the input directivity (*EW* components > *NS* components in the records) on the building damages, the damage distributions of the buildings along the *N-S* and *E-W* streets are shown in Figure (8). The building damages along the *E-W* street are estimated to be larger than those along the *N-S* street considering the horizontal irregularity due to arrangements of openings in buildings along the streets, whereas the statistics result does not show significant directivity of the building damages.

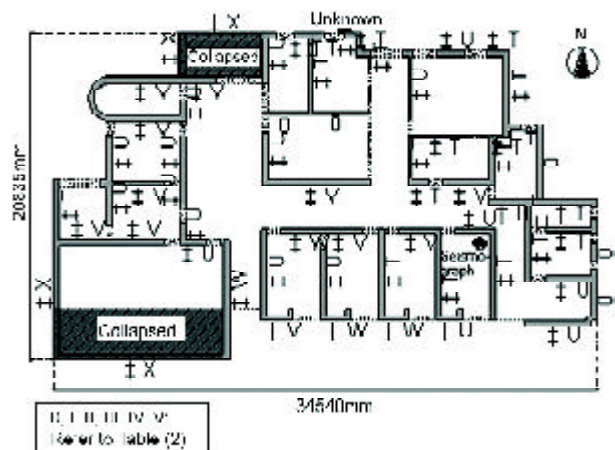
Figure 9. First floor plan and damage levels of masonry walls of Governor's building.

Governor's Building is a two-story *SM* building with reinforced concrete horizontal ties, as shown in Photo (1). This building has an irregular plan. The wall arrangement is illustrated in Figure (9). The damage level, classified by *EMS-98*, was Grade 4 due to the partially collapses of *NW*- and *SW*-sections as shown in Photo (2). The location of the seismograph is also illustrated in Figure (9), which shows that the seismograph was placed far from both collapsed areas. The wall ratios (= the sum of the first floor wall sectional area / the first floor area) were 6.4% to 6.8% in the *NS* direction and 5.8% to 6.7% in the *EW* direction considering the unknown collapsed area.

Moreover, the damage levels and the maximum crack widths of all masonry walls in the first story were measured in Governor's Building according to the criteria shown in Table (2). The damage levels of walls are also shown in Figure (9) and the

distribution of the wall damage level in each direction was shown in Figure (10). The averaged damage level of all walls in the *EW* direction of 2.3, which is calculated as the mean value of damage levels of walls in Figure (10), is larger than that in the *NS* direction of 1.7, which means the directivity of the input motions, estimated by the wall ratios (*NS*~*EW*) and damage levels (*NS*<*EW*), corresponds to that of the actually recorded data (*NS*<*EW*).

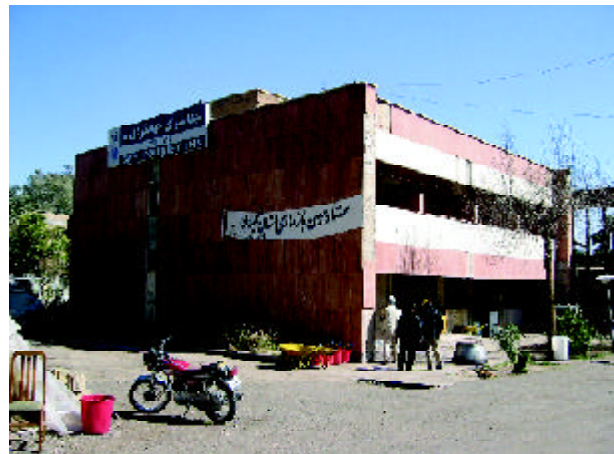
Bam Tourist Inn, used as hotel and restaurant, is a two-story SM building as shown in Photo (3). The plan of this building is relatively regular, see Figure (11). The damage level, classified by *EMS-98*, was as low as Grade 2 as estimated from Photo (3),

Photo 3. South west view of Bam Tourist Inn.

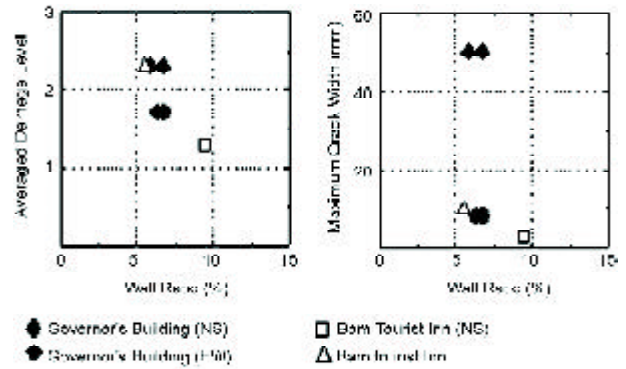
Figure 13. Relationships between the wall ratio and the wall damage level.

Figure (13) shows the relationships between the wall ratio and the averaged damage level and correlation between the wall ratio and the maximum crack width, respectively. It can be concluded from Figure (13a) that the averaged damage levels were larger in case of smaller wall ratio. The maximum crack widths were also larger in case of smaller wall ratio

among the NS direction of Governor’s Building and both directions of Bam Tourist Inn, as shown in Figure (13b). However, the maximum crack width in the EW direction of Governor’s Building was much higher than those in the other cases. This may be caused by the torsional responses due to the horizontal irregularity of Governor’s Building, because the larger crack widths were observed in the outside walls. The building damages can not be clarified in detail based on only the wall ratio as mentioned here, however, it can be concluded that the wall ratio is considered to be one of the reliable indexes for evaluating the seismic performance of unreinforced masonry buildings.

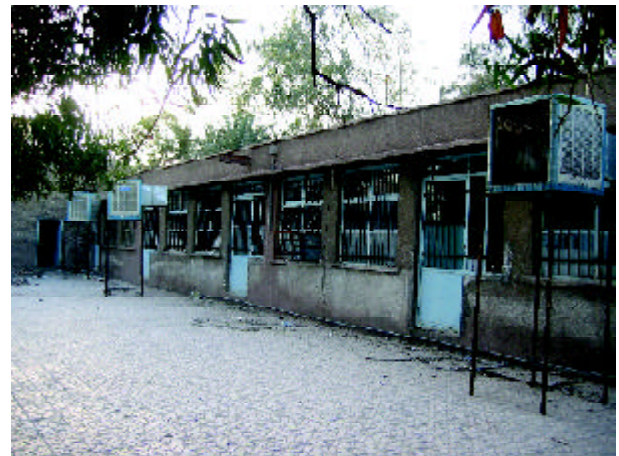
17 Shariwar High-School is located a few hundreds meter west of Governor’s Building and consists of three SM buildings. The two single-story buildings escaped severe damage, as shown in Photo (5), although minor cracks were found on brick walls. On the other hand, the two-story building was partially collapsed, see Photo (6). This building consists of intermediate steel frame and exterior brick walls. The floor slab system is a jack arch type, mentioned earlier. The floor plan of the collapsed part is shown

Photo 5. Single-story school building (slight damage).

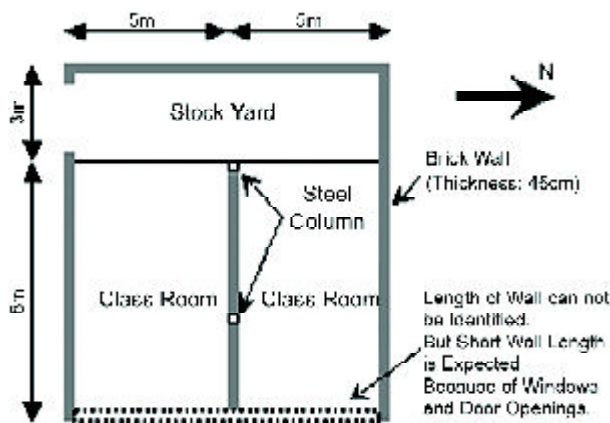
Figure 14. Floor plan of collapsed part of two-story school building.

in Figure (14). The roof and floor slab fell off due to the collapse of an east exterior brick wall.

The wall area ratio in the first story is obtained as 4.1% in *NS* direction and 11.0% in *EW* direction. Note that the value in *NS* was calculated assuming that the area of collapsed east exterior wall is 0, not only because thickness and length of the collapsed wall could not be identified but also very short wall length may be expected due to existence of the windows and doors. The wall area ratio in *NS* direction of 4.1%, in which severer damage occurred, is less than values of the two buildings mentioned before.

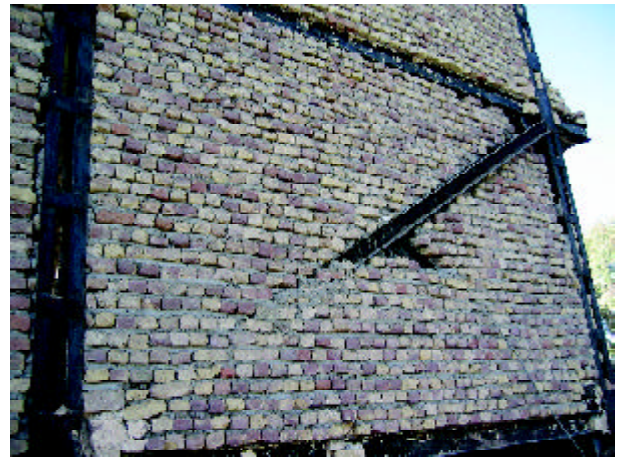
In the first story, fractures of welding joint and buckling of steel brace were observed, see Photos (8) and (9), and as a result, the brick walls were collapsed. Damage to the brick wall in the second story, see Photo (10) was also observed. No remarkable structural damage to the steel columns in *NS* direction was found, although bricks fell off the facade of the building.

Photo 10: Buckling of steel brace and damage to brick wall.

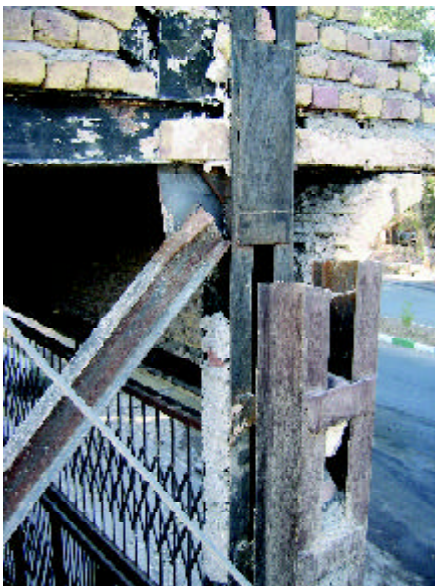
Photo 8. Fracture of welded joint of a steel brace.

and (4) floor area is $5.7m \times 16m = 91.2m^2$. These assumptions give a base shear coefficient, C , of 0.33. This base shear coefficient is relatively lower than the approximated values for both Governor's Building and Bam Tourist Inn. This may be one reason why this building suffered severe damage. Other reasons may be poor quality of welding, see Figures (8) and (9), and unconfined brick walls.

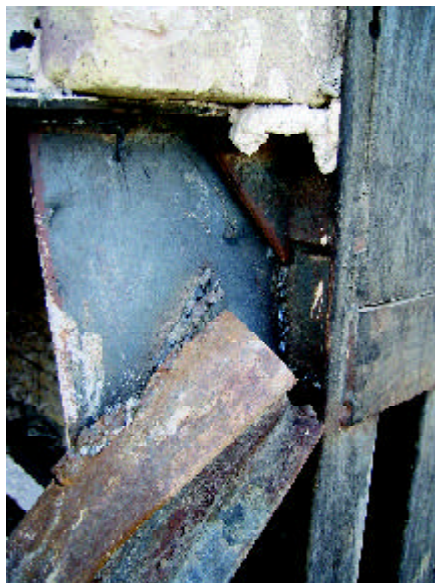
Photo 9. Close-up of Figure (8).
