# Performance of RC Structures and Associated Lessons to be Learned from November 12, 2017, Sarpol-e Zahab - Ezgeleh Earthquake ( $M_w$ 7.3)

Sarpol-e Zahab - Ezgeleh Earthquake; RC structures; Failure types; Seismic code

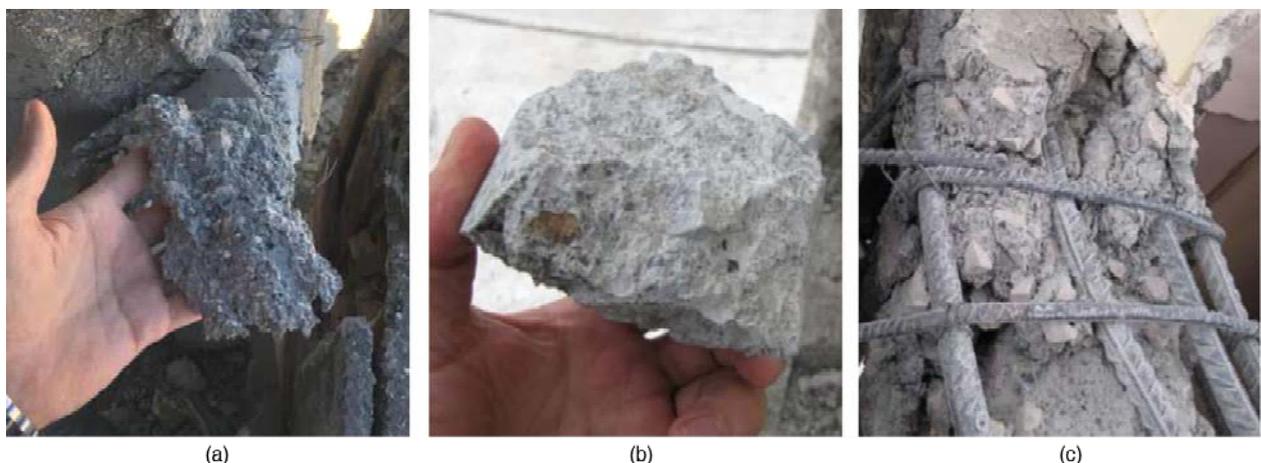
Poor quality of concrete is one of the most important causes of structural damages and building failures. The damages caused by poor quality concrete in earthquakes, has been reported by many researchers in recent decades [2-3]. Based on the observations, the quality of the concrete used in the damaged buildings was considerably poor. Examples of the use of low-quality concrete are shown in Figure (3). In earthquake

affected region, utilization of hand-mixed concrete especially for residential buildings is the common construction practice. According to the observations, lack of sieve analysis resulted in oversized aggregates and poor gradation concrete mixture, high water to cement ratio, insufficient concrete curing and lack of vibration after concrete placement are the most important mistakes in mixture of concrete material.

Figure 3. Use of low quality concrete.

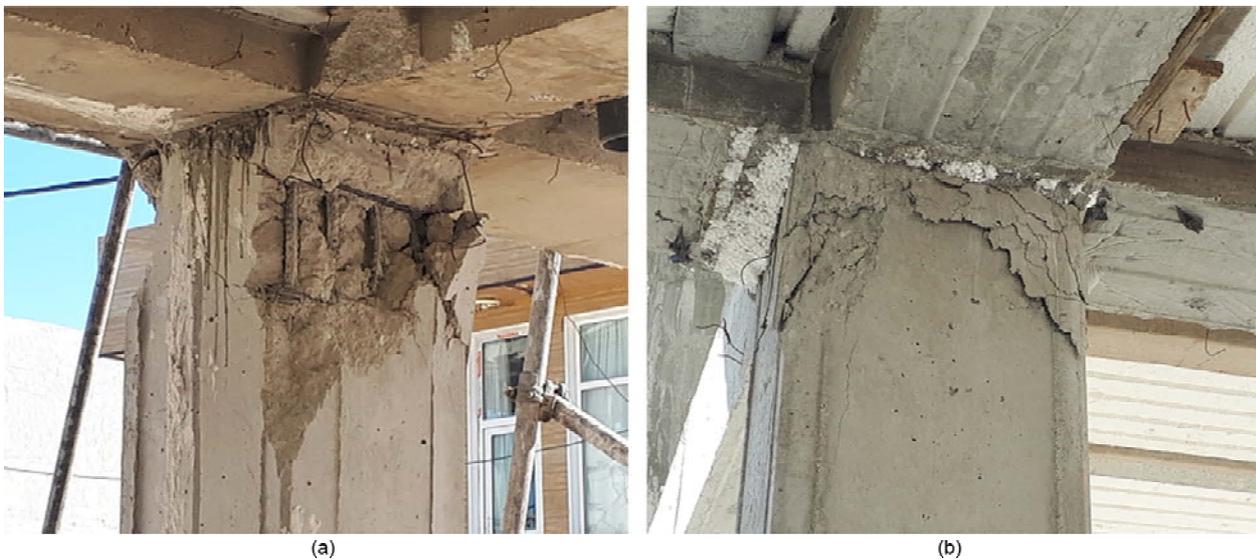
As expected, given the fact that meeting the strong-column / weak-beam requirement is not mandatory in intermediate or ordinary RC buildings, based on ACI-318 [4] and Iranian seismic code [1], strong beam / weak column connections were observed in the RC buildings in the earthquake affected region. Examples are presented in Figure (4). In general, the ductility capacity of structures, with weak columns compared to the beams, is significantly reduced and in the worst case of weak columns, flexural yielding can occur at both ends of all columns in a given story, resulting in a column failure mechanism that can lead to collapse [4]. Figure (5) shows the case study of a new 3-story residential building in Sarpol-e Zahab city. Severe damage occurred at both ends of columns in first stories, while no considerable damage was observed at the beam ends.

Figure 4. Damages due to strong beam-weak column.

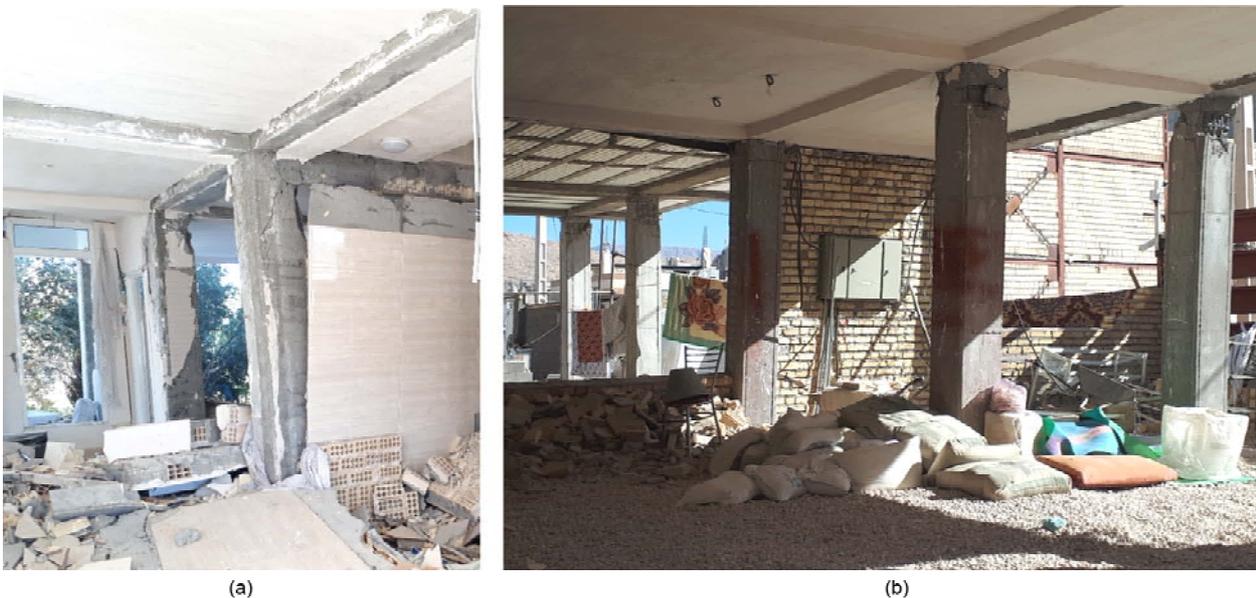
Figure 5. Case study: A 3-story RC building, damages due to strong beam-weak column.

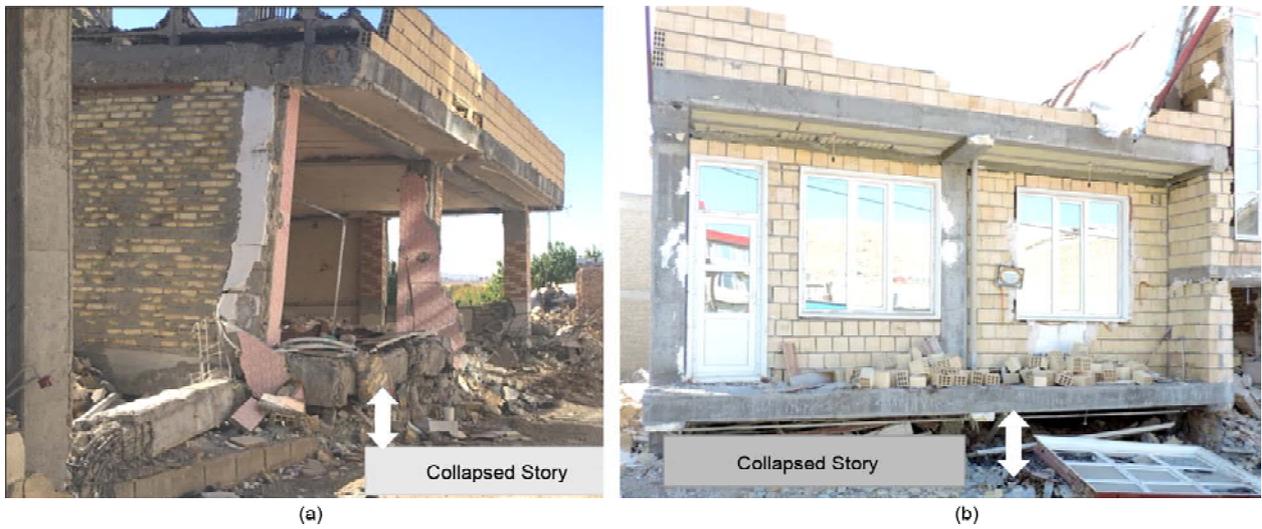
not provided any mandatory regulations to avoid "soft story" in regular buildings with the height less than 50 meters, or all structures (regular or irregular) with three story or less. While, according to the observations, low-rise RC moment frame buildings, are also significantly vulnerable to soft story-related damages (Figure 6).

Figure 6. Soft story phenomenon.

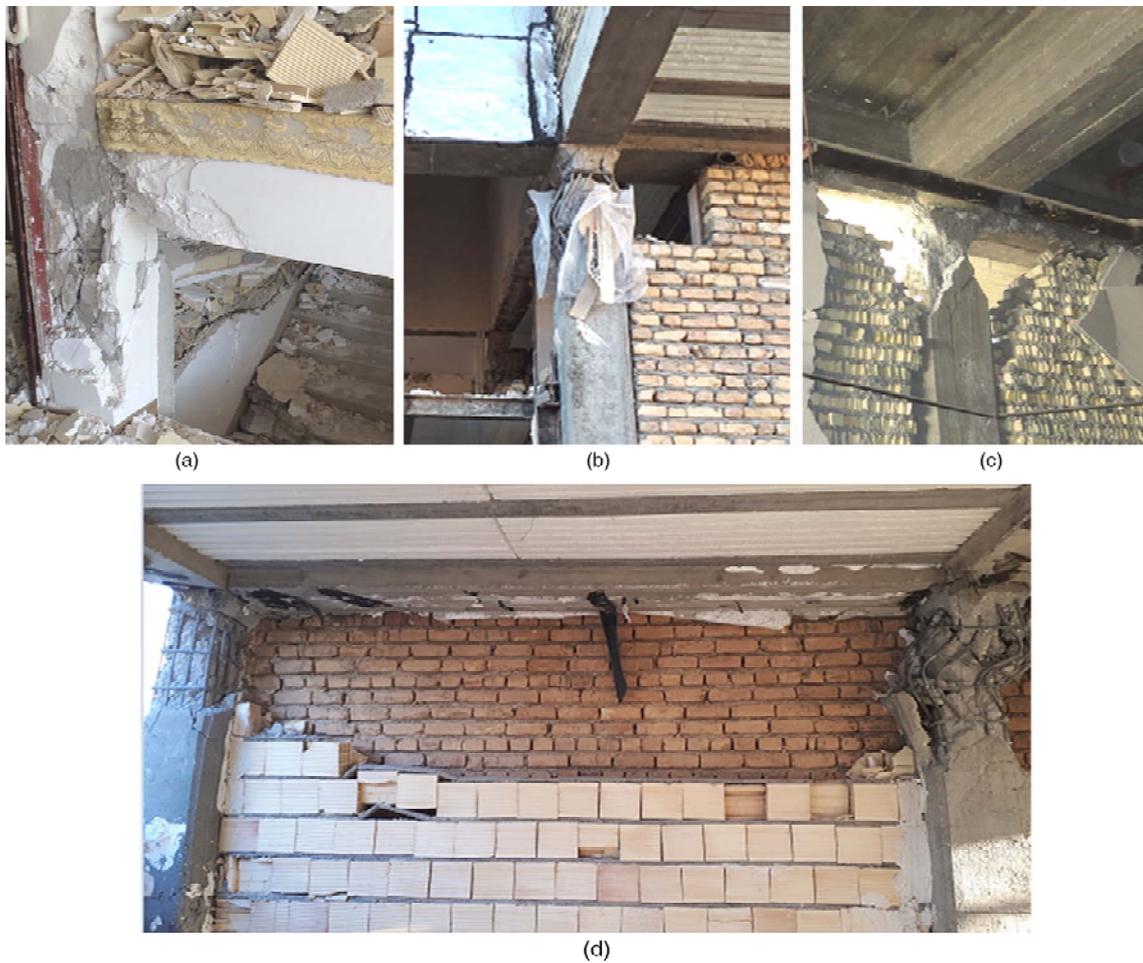
Short column collapse were widely observed during the field observations, such as the cases shown in Figure (7). The short columns have much higher lateral stiffness in comparison with normal columns and higher seismic loads can develop in

Figure 7. Short column effect.

such columns and may result in double diagonal cracking failure. Figure (7a) shows the formation of a short column due to the intermediate staircase landing between two floors, Figure (7b) shows the short column effect due to the partial infilled frames to attain architectural requirements and

finally, Figures (7c) and (7d) indicates the generation of a short column due to the partial collapse of infill walls. Proper seismic detailing, with closer stirrup spacing specially for columns prone to shear failure due to the short column effect, is required to prevent short column failures.

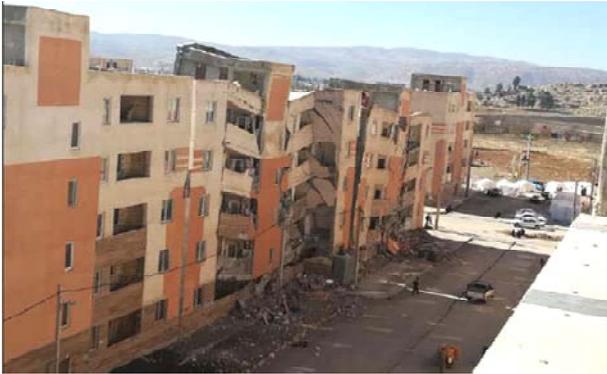
Shear wall collapse, particularly in Sharafabad town, close to Eslamabad-e Gharb city, was observed. As mentioned before, the maximum recorded PGA for the earthquake in Eslamabad-e Gharb city was negligible (0.12 g) and the damage to the shear walls was concentrated to only two adjacent buildings while the other buildings in this town, did not experience severe structural damage due to earthquake (Figure 8)

**Figure 8.** Collapse of structures with dual LFRS (moment frame and Shear wall) in Eslamabad-e Gharb.

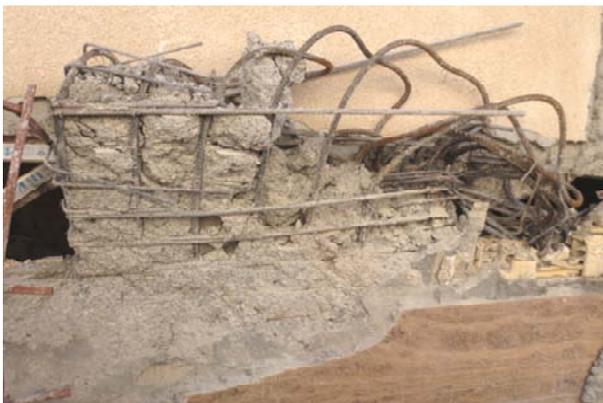
(a)

**Figure 9.** Collapsed shear walls.

reinforcement is required for axial strength in structural walls or if the ratio of longitudinal reinforcement to gross wall section area exceeds 0.001, longitudinal reinforcements shall be laterally supported by transverse ties. As shown in Figure (9a), widespread buckling of longitudinal reinforcement observed, due to the lack of transverse ties. Large spacing and inappropriate anchorage of transverse reinforcement, ignoring the lateral support of longitudinal reinforcement by transverse ties, impaired the efficiency of the shear walls, remarkably.

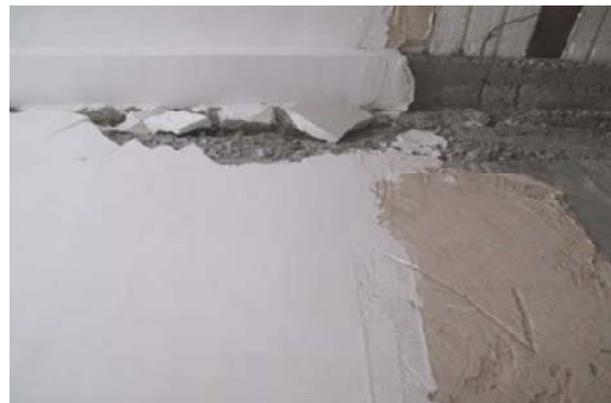
(a)

walls in first story was considered as the probable location, corresponding to onset of shear wall damage, influenced by poor concrete quality at the top of walls. As well as poor quality of concrete, other deficiencies can be considered as the cause of shear wall collapse as follows:

**Figure 10.** Poor concrete quality at the top of shear walls.

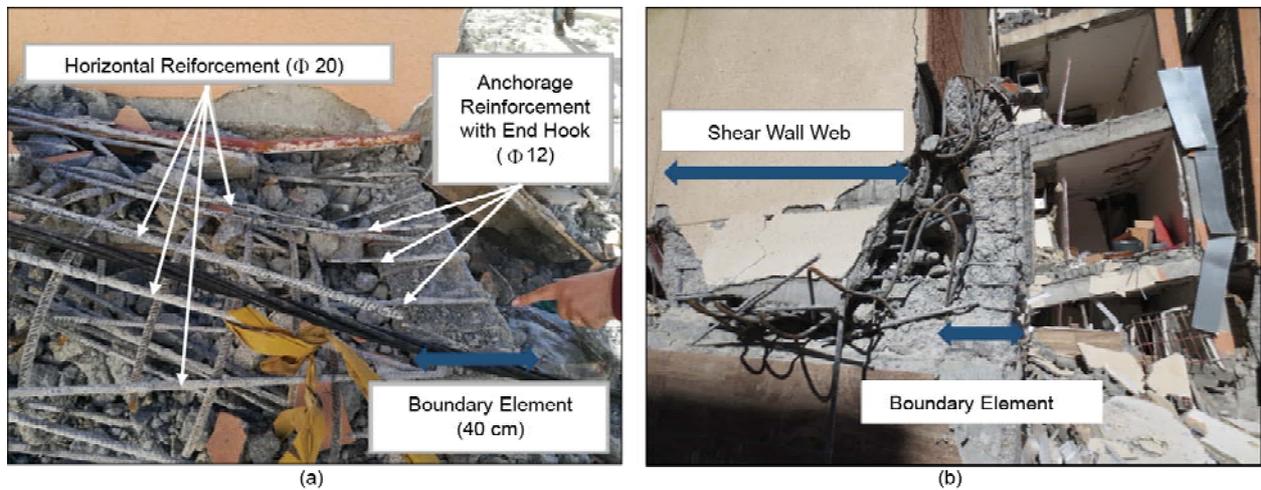
- ❖ According to ACI-318, the shear horizontal reinforcement requires to extend to the edge of the wall to be anchored to develop yield stress in tension within the confined core of the boundary element using standard hooks or heads. As shown in Figure (11), significant deficiencies observed in anchorage of horizontal reinforcements in the boundary elements. The diameter of anchorage segments in boundary zones, was much less than diameter of horizontal reinforcement in the wall web, with insufficient splice length and was placed out of the boundary element core. As a result of deficiencies in anchorage of horizontal reinforcements, severe detachment between boundary elements and the shear wall web observed in collapsed blocks.
- ❖ According to ACI-318, if longitudinal

Figure 11. Detachment of boundray element and shear wall web due to the deficiencies in anchorage of horizontal reinforcements.

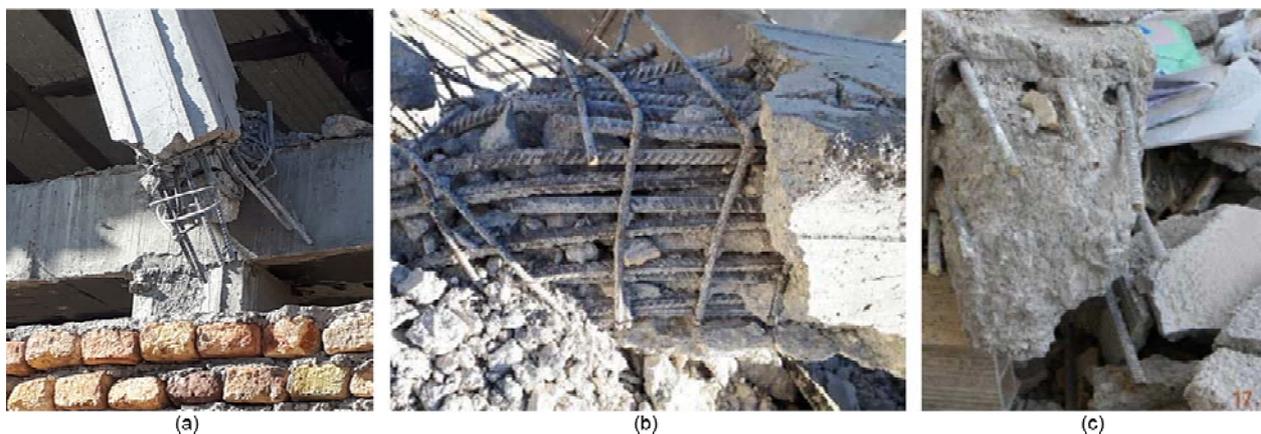
Figure 12. Short splice length and splices near joints.

A widespread failure mode observed in RC buildings was the inadequate splice length of longitudinal reinforcements especially near beam-column joints, which is an undesirable location for splicing, as shown in Figure (12). Short lap splices at plastic

hinge regions, lack of end hook angle, and widely spaced stirrups increased the severity of the damage.

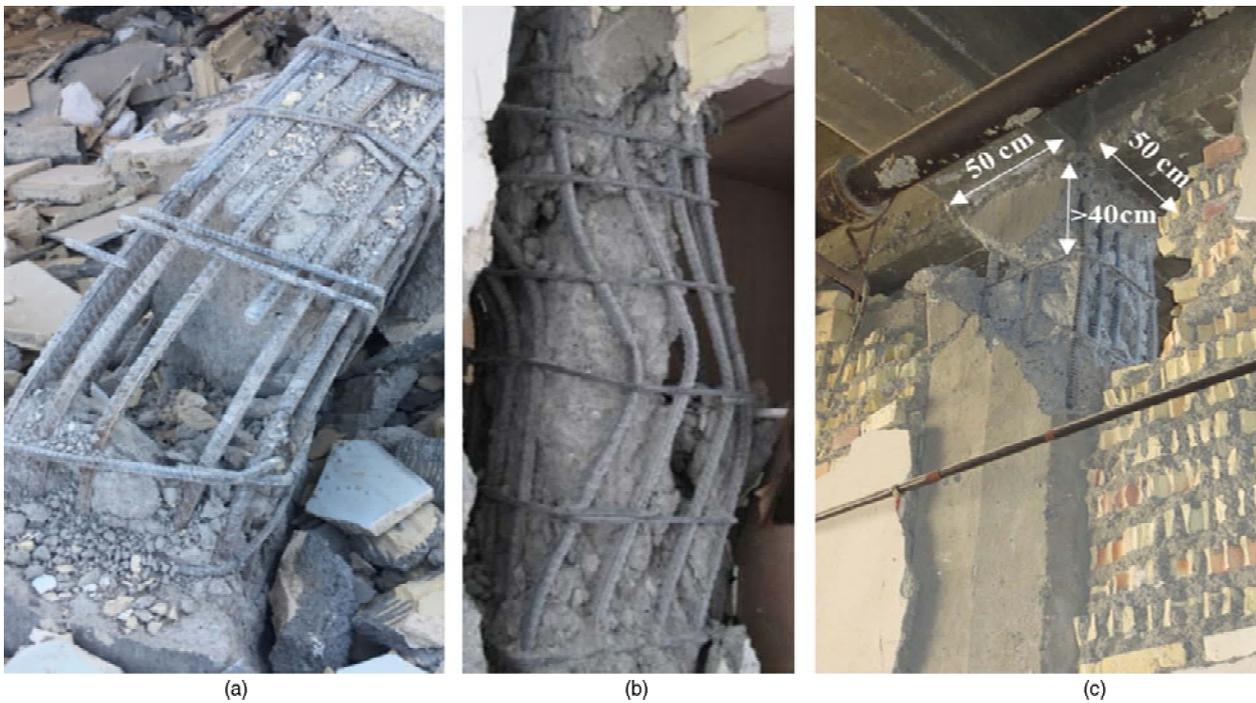
As is shown in Figure (13), the stirrup arrangements in the columns of damaged RC buildings were poorly detailed. The length of the hook provided in stirrups was short and had inappropriate 90° - end hooks. Excessive spacing of transverse reinforcement throughout the column, even in hospital building with the highest design importance factor as shown in Figure (13c). The maximum spacing according to confinement requirements of ACI 318 [4], for a column with characteristics shown in Figure (13c) is about 70 mm while the stirrups spacing is more than 400 mm as shown in Figure (13c). This caused shear failures, buckling of longitudinal rebar and poor confinement of the core concrete.

Figure 13. Insufficient and inappropriate stirrups detailing.

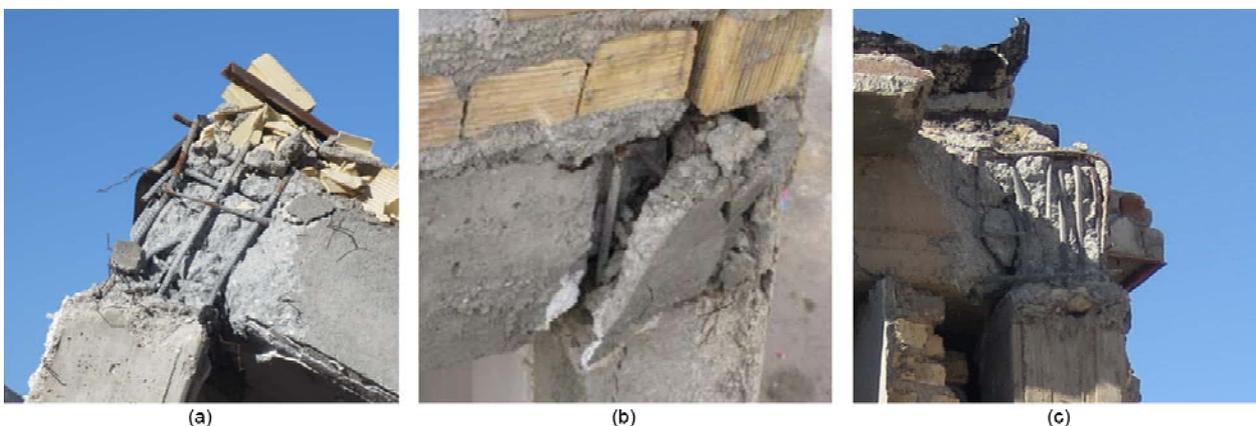
lack of standard end hooks at the end of column longitudinal rebars was observed in the majority of the damaged beam-column joints, as shown in Figure (14).

Figure 14. Failure of beam-column joints.

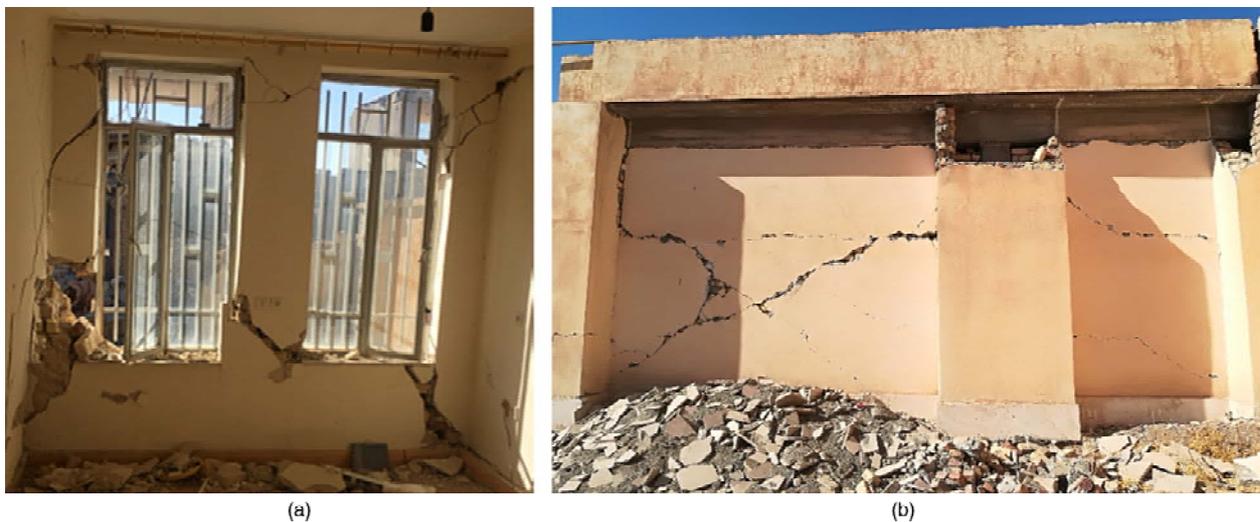
**Figure 15.** In-plane failure modes of infill walls. (a): Cracking in wall piers, induced by the location and size of openings. (b): In-plane failure due to diagonal cracking induced by weak components and joints.

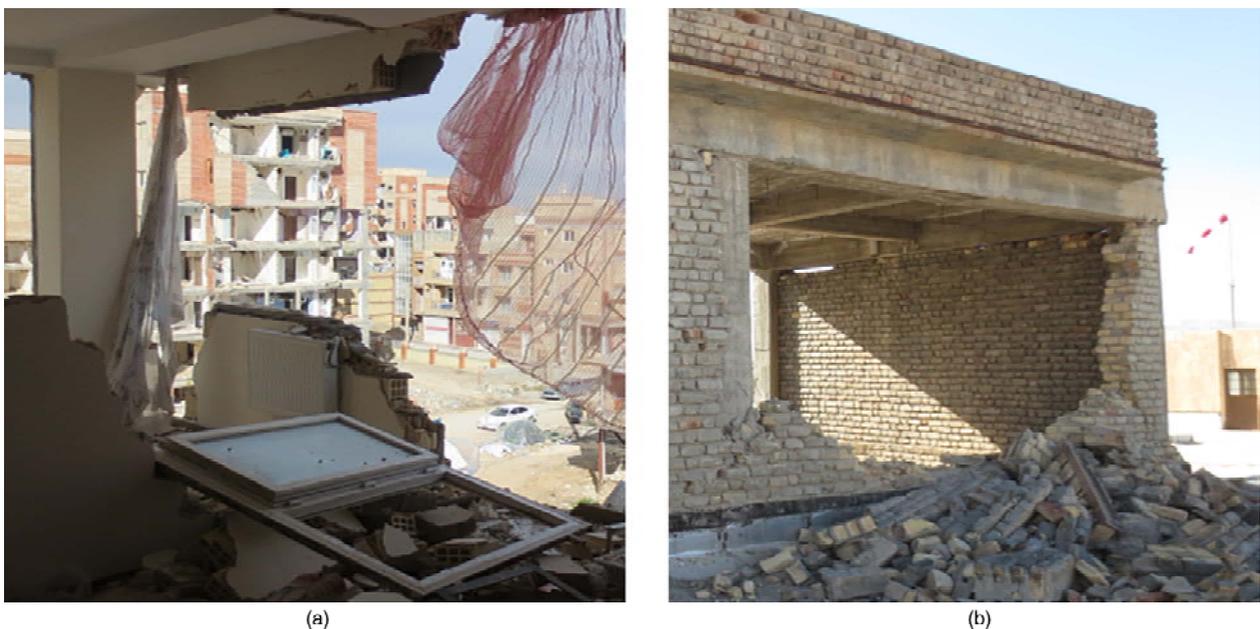
of the infill walls, their inability in accommodating the large drifts experienced by the building and finally, deficiencies in anchorage of the infill wall and proper connection between infill walls and the structure. According to the in situ observations, undesirable seismic response of infill walls can be organized in three general categories as mentioned in Noorifard et al. [6]. At the first category, only the infill walls are damaged by in plane failure (Figure 15). At the second category, there is the possibility of other non-structural elements damage and human injury as well as the wall damage by the out of plane failure of infill walls (Figure 16). At the third category, the arrangement of walls in plan and

**Figure 16.** Out of plane failure of infill walls induced by weak components and joints.

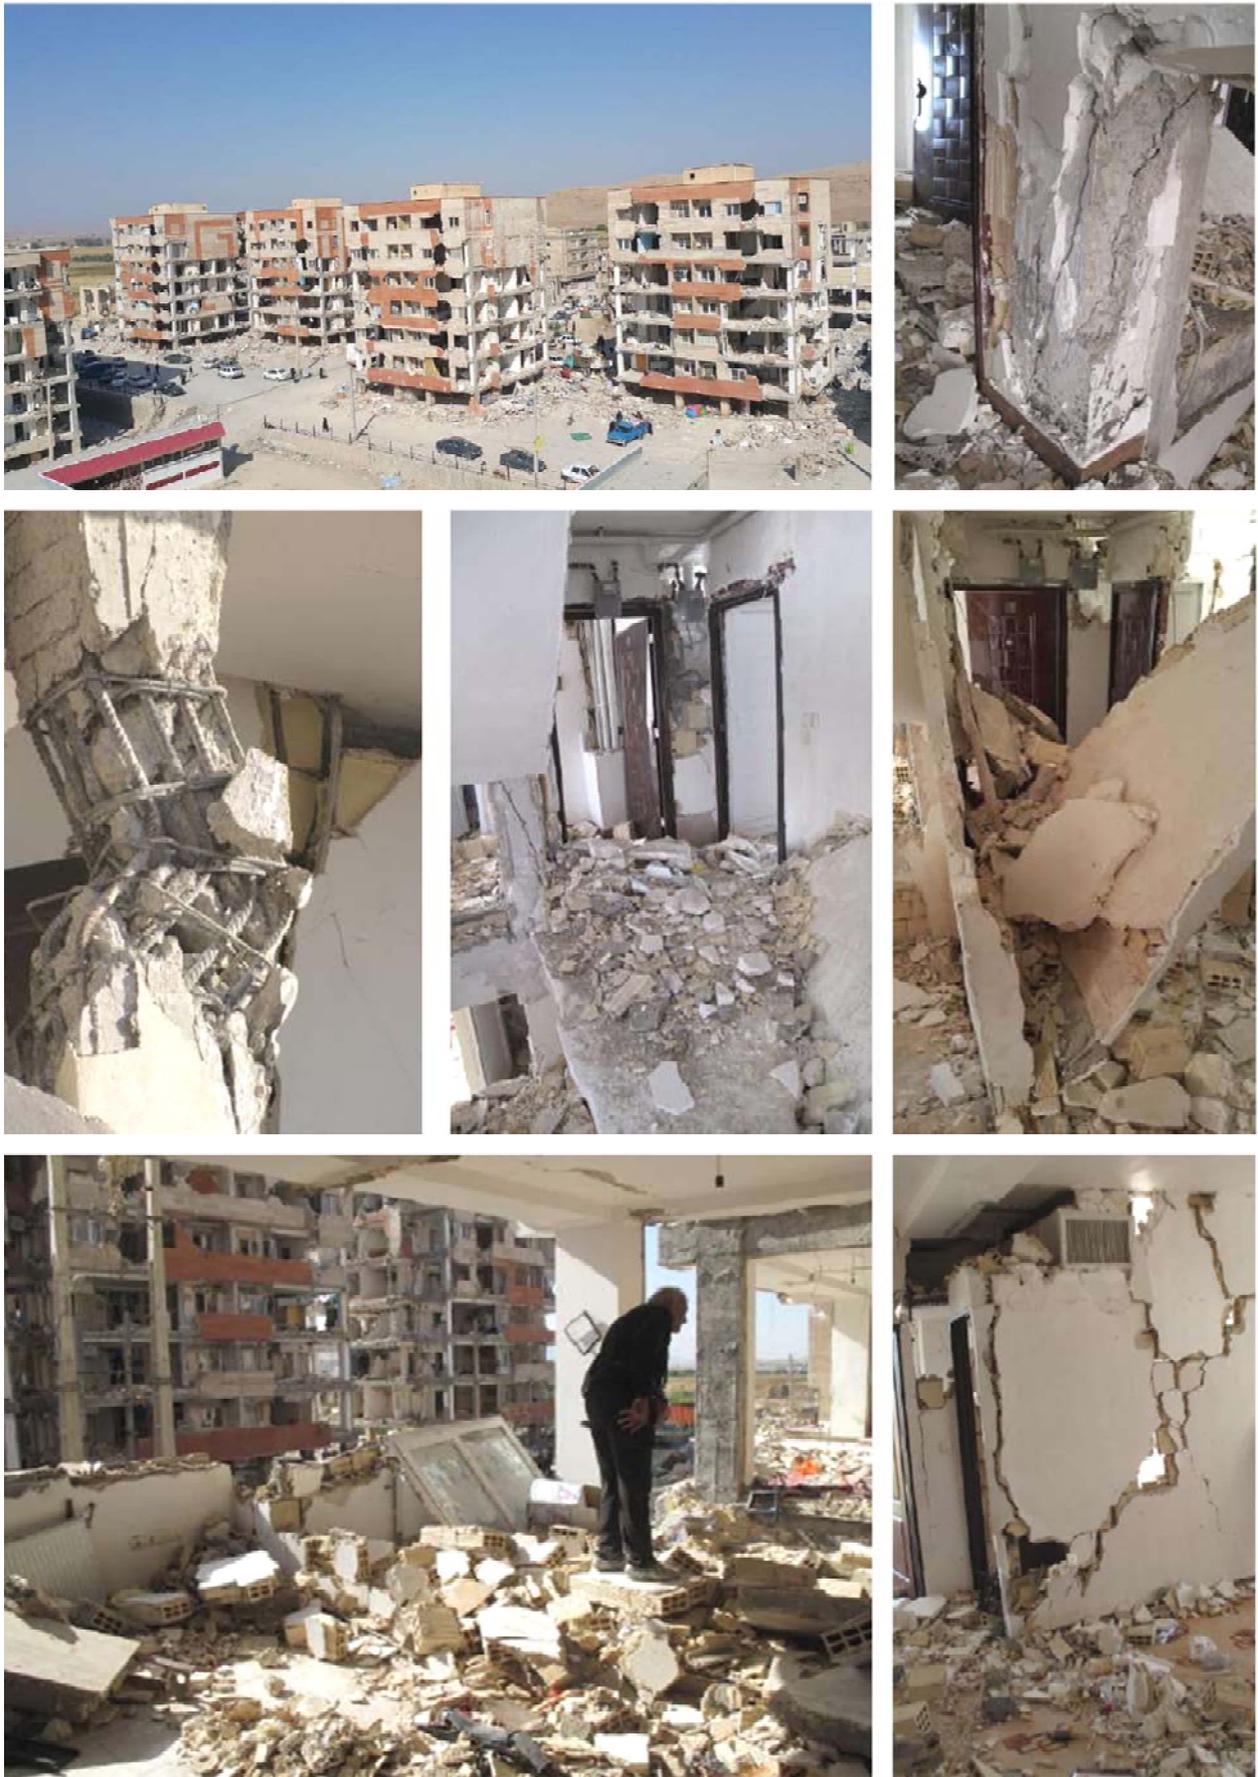
| Town | City | Location | Year Built | Number of Blocks | Number of Floors | Lateral-Force Resisting System (LFRS) | Observed Damages | | Related Figures |
|---|---|---|---|---|---|--|---|---|---|
| Shahid Shiroodi | Sarpol-e Zahab | 34.46° N<br>45.84° E | 2012 | 24 | 7 | IMF* in N-S Direction & DUAL** in E-W (100%) | Short Column (100%)<br>Column Overall Buckling (20%) | Extensive, Out-of-Plane Failure of Infill Walls (100%) | Figure 7a<br>Figure 16a<br>Figure 17 |

**Figure 17.** Observed structural and non-structural damages in Shahid Shiroodi town.

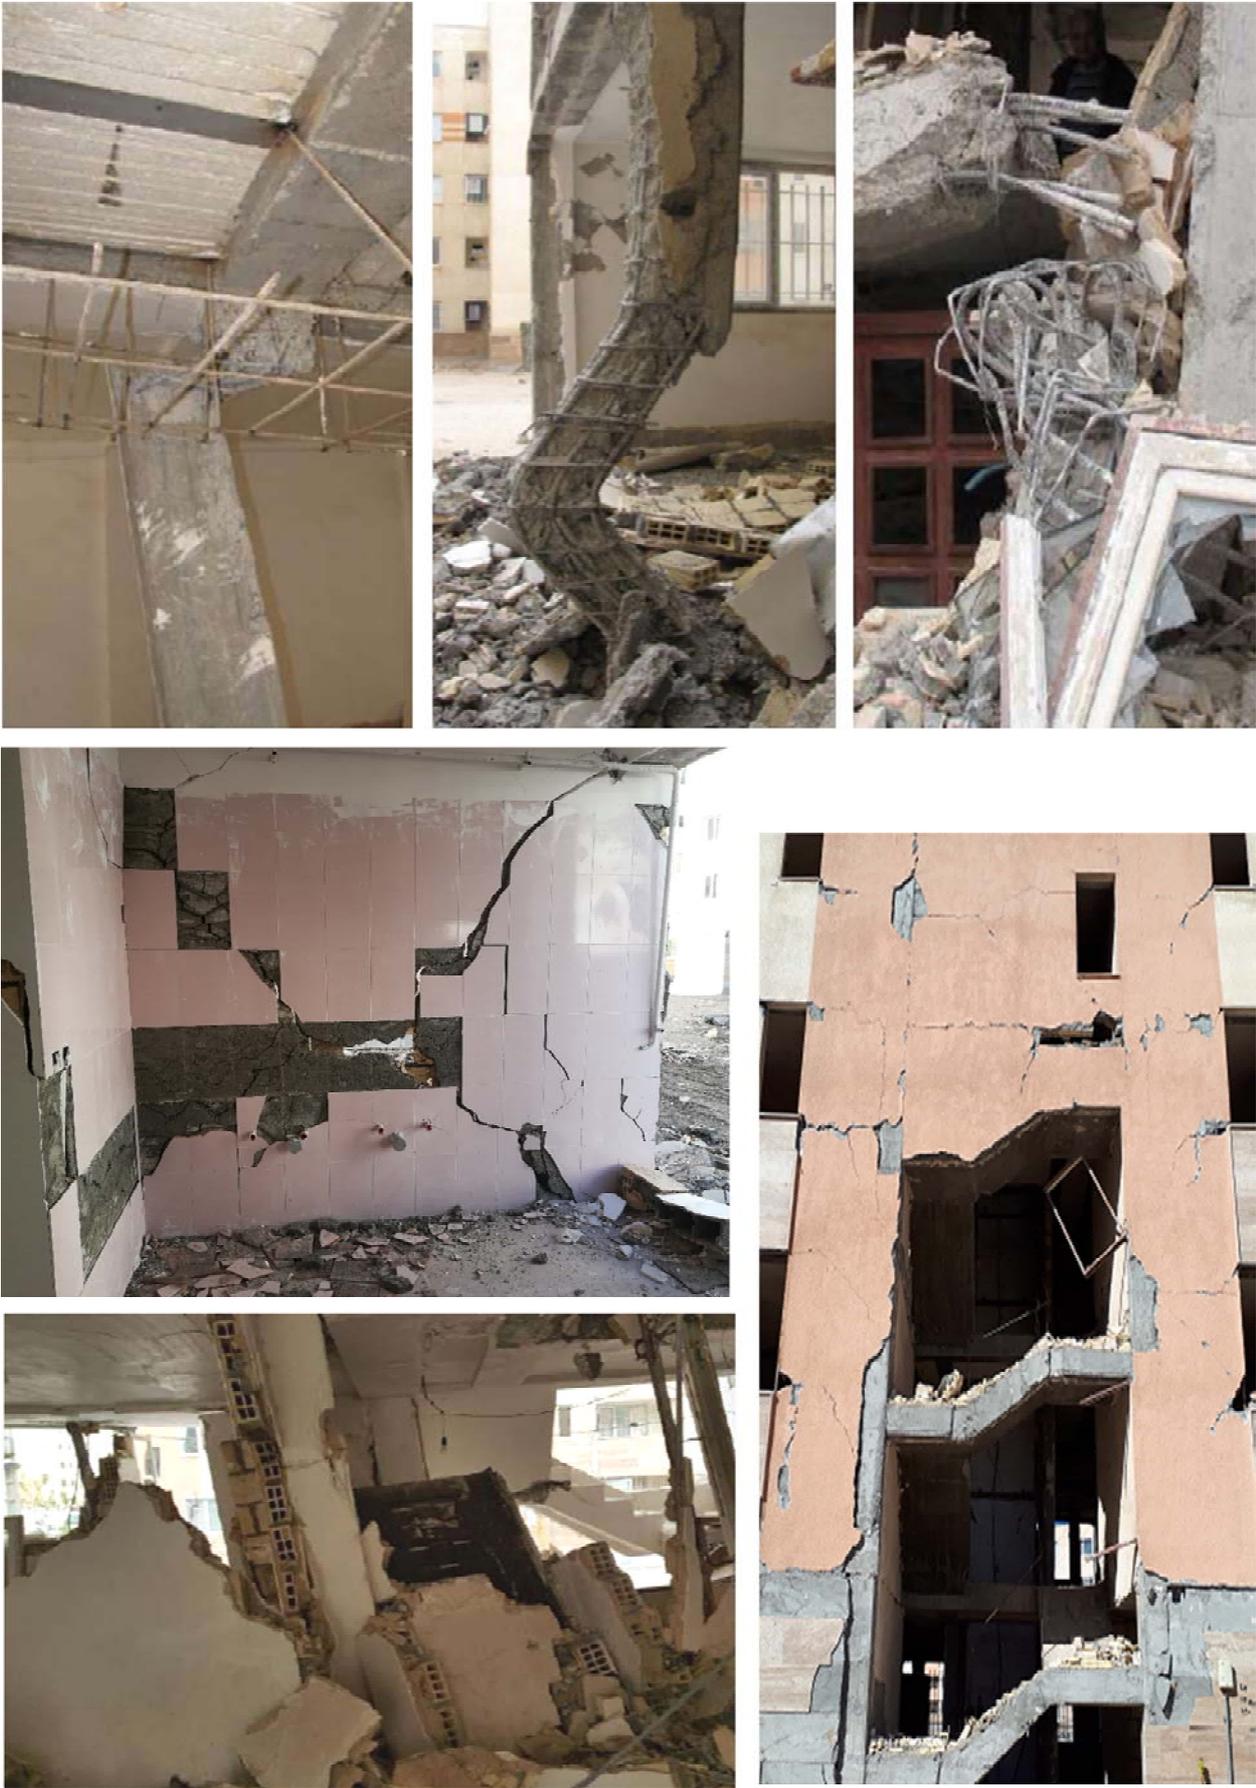
| Town | City | Location | Year Built | Number of Blocks | Number of Floors | Lateral-Force Resisting System (LFRS) | Observed Damages | | Related Figures |
|---|---|---|---|---|---|--|---|---|---|
| Sharafabad | Eslamabad-e Gharb | 34.07° N<br>46.30° E | 2017 | 99 | 5 | DUAL (50%)<br>IMF (50%) | Complete Structural Collapse in Two Adjacent Blocks with DUAL LFRS as Discussed in Detail in Section 2.5 (2%)<br>No Significant Damage Observed for Other Buildings (98%) | Out-of-Plane Failure of Infill Walls (10%)<br>Minor In-Plane Cracks (10%) | Figure 8<br>Figure 9<br>Figure 10<br>Figure 11<br>Figure 18 |

**Figure 18.** Observed structural and non-structural damages in Sharafabad town structures.

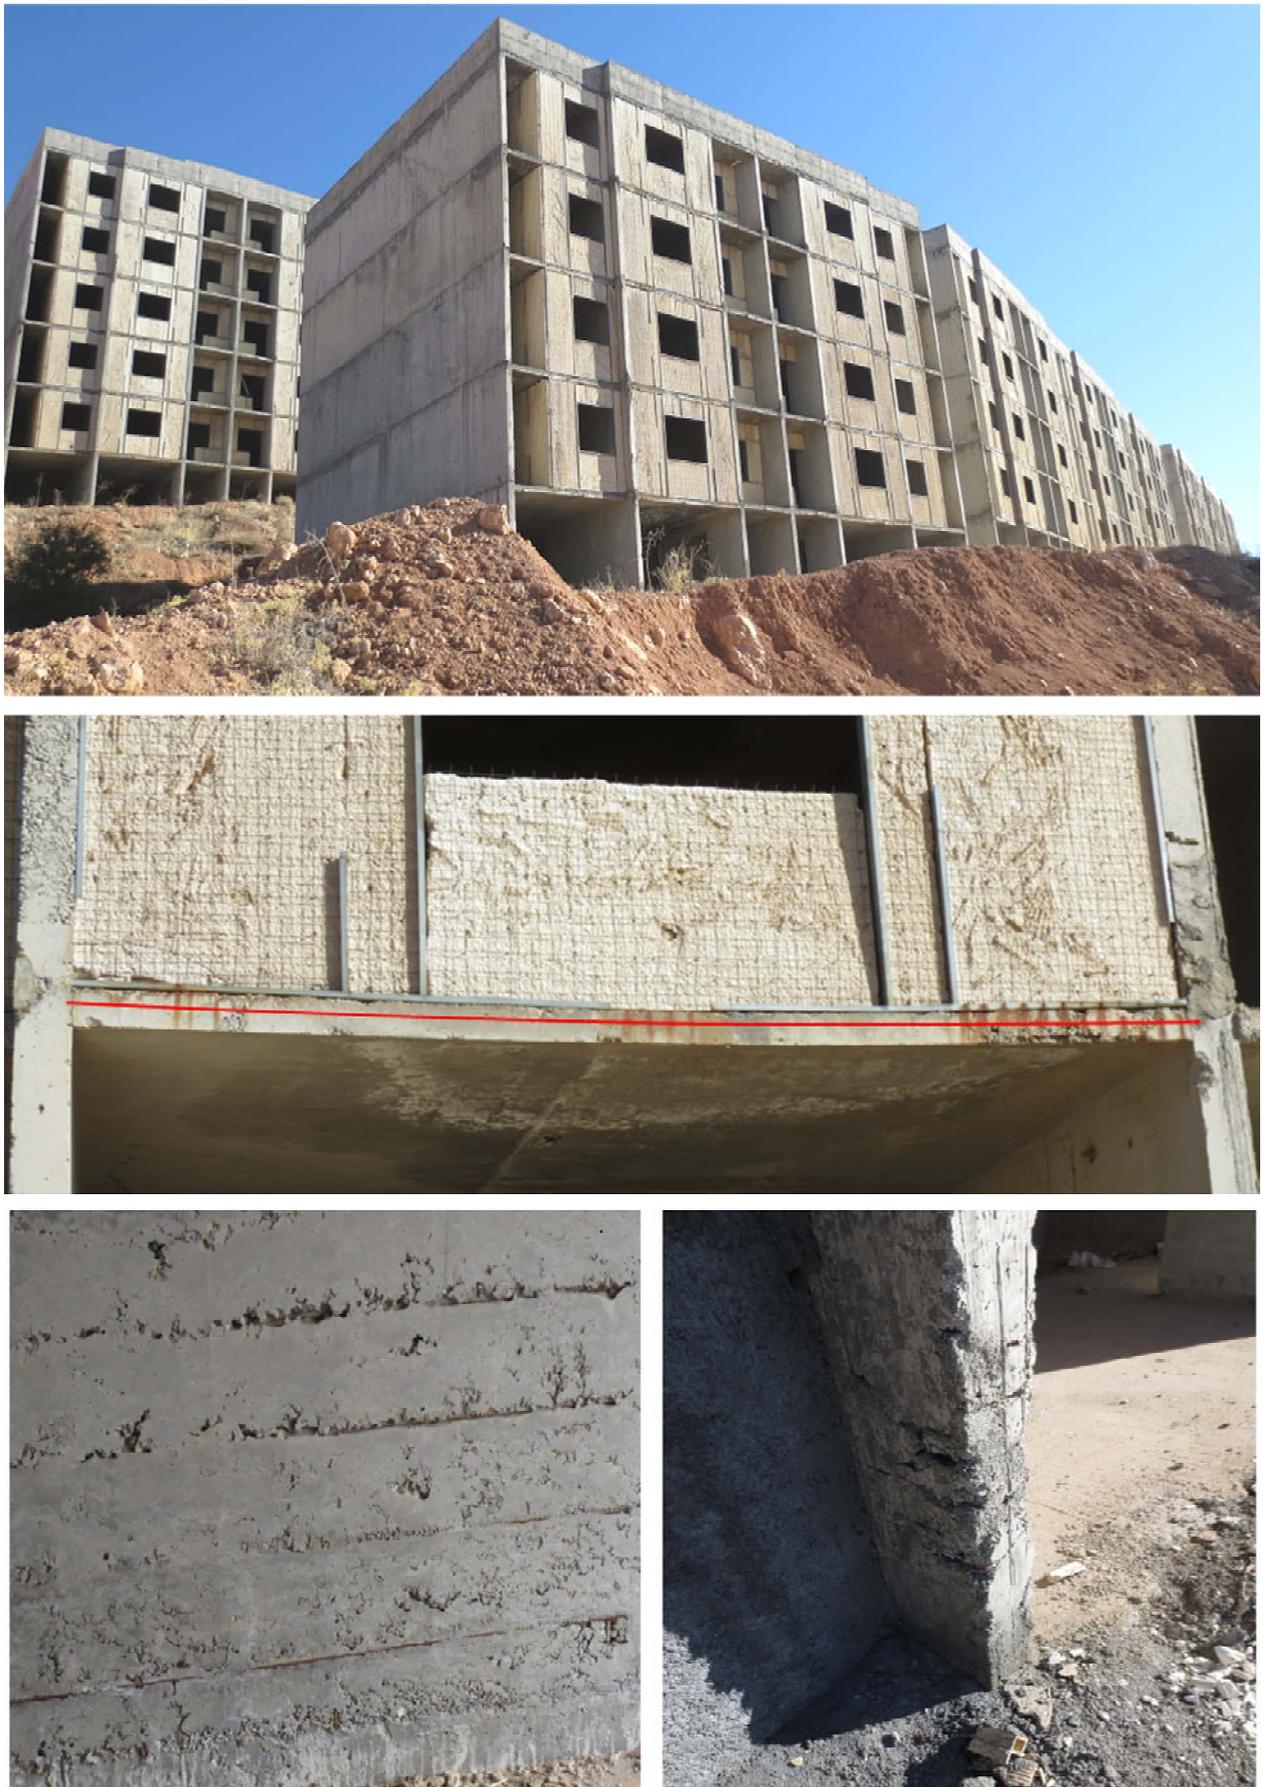
| Town | City | Location | Year Built | Number of Blocks | Number of Floors | Lateral-Force Resisting System (LFRS) | Observed Damages | | Related Figures |
|---|---|---|---|---|---|--|---|---|---|
| Dalahoo | Kerend-e Gharb | 34.27° N<br>46.25° E | Under Construction | 23 | 5 | Tunnel Form*** (100%) | Due to Negligible Acceleration of Earthquake in This Area, no Obvious Damages Due to the Earthquake Observed. Although Significant Construction Deficiencies Observed During the Visit as Shown in Figure (19) (100%) | | Figure 19 |

**Figure 19.** Observed structural damages in Dalahoo town structures.
