Soil Dynamics and the Earthquake Destruction of the Earthen Architecture of the Arg-e Bam

Randolph Langenbach

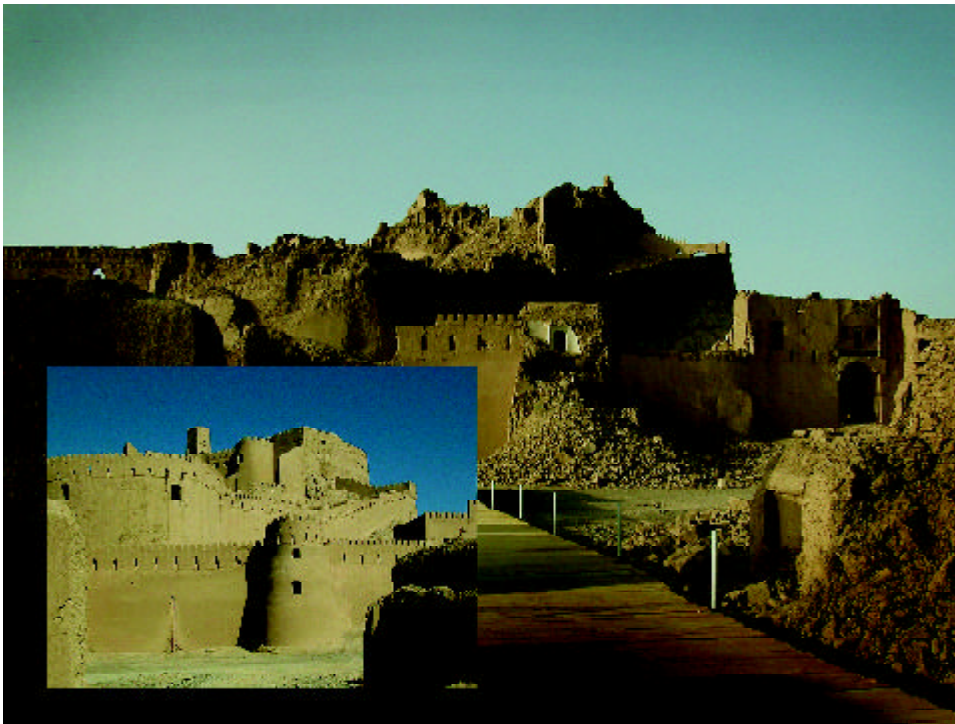
Figure 1. The Arg-e Bam upper citadel before and after the earthquake. Before photo by James Conlon, 2003.

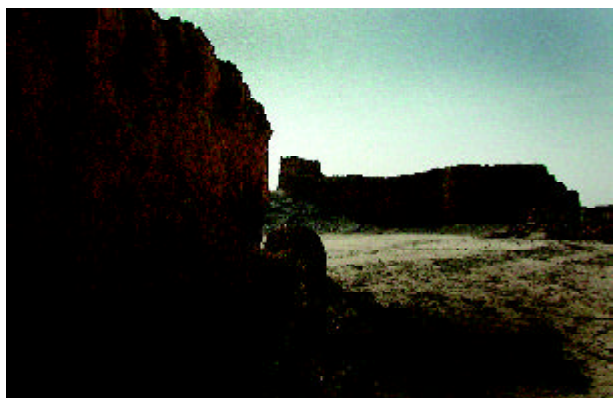
Figure 3. Unrestored ancient earthen structures including the Shahrbast Wall in the distance after the earthquake. These structures were only lightly damaged.

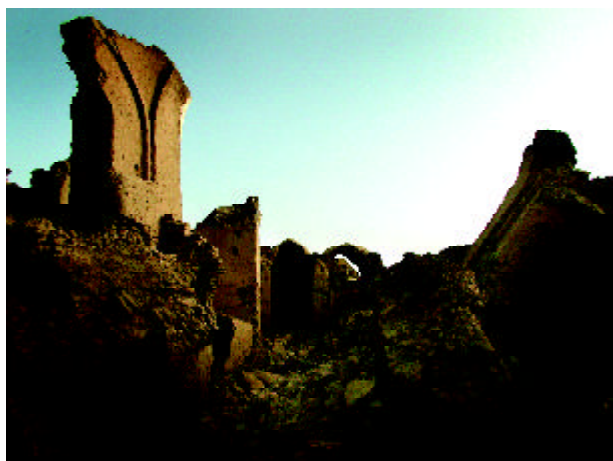
Figure 4. View of the ruins of the Arg-e Bam.

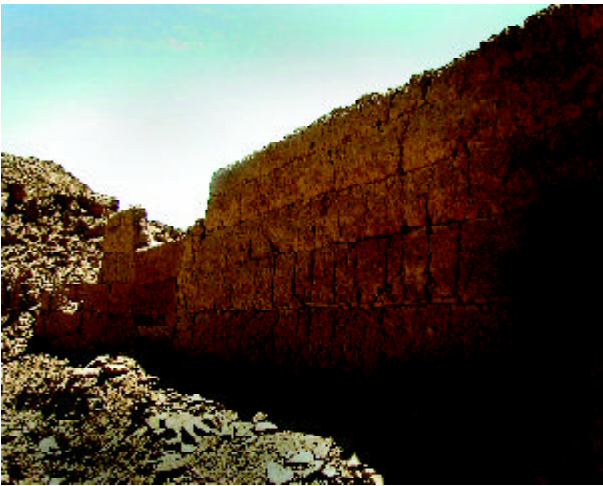
Figure 5. Chineh wall inside the Arg-e Bam that was only slightly damaged in the earthquake.

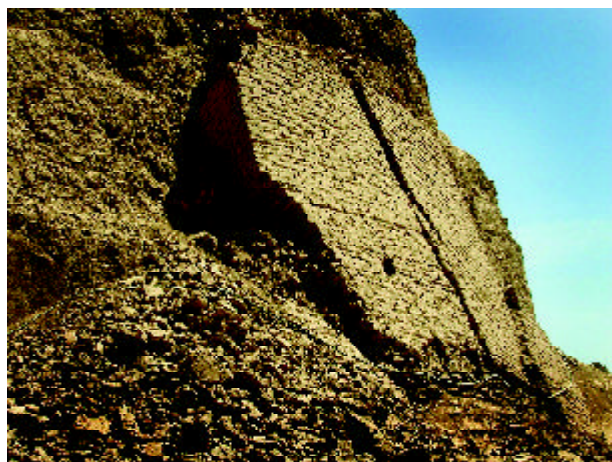
Figure 7. View of collapsed outer walls of a round tower. The Khesht construction of the outer layer has fallen off of the earlier inner layers that are most likely a combination of periods of building in different methods.

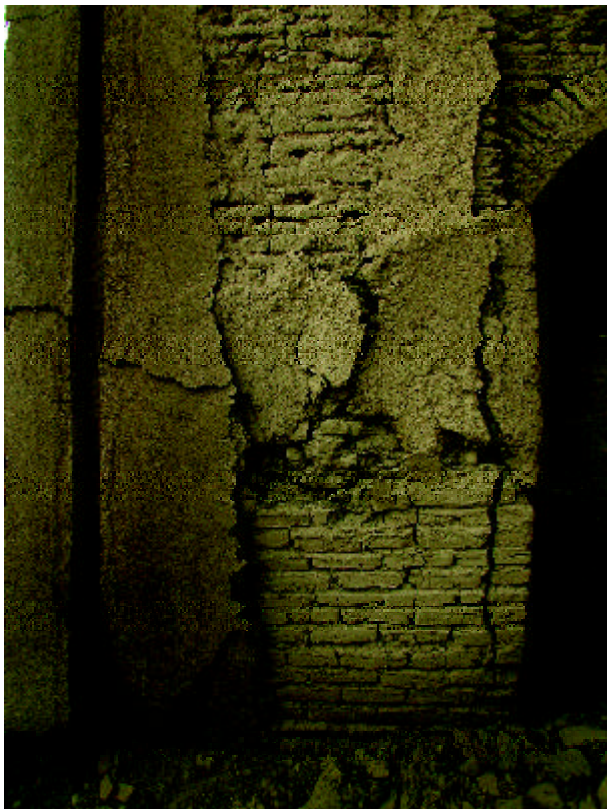
Figure 8. Pier in a partially collapsed section of the Caravansary showing the bursting of the outer layers from internal expansion from the earthquake vibrations.

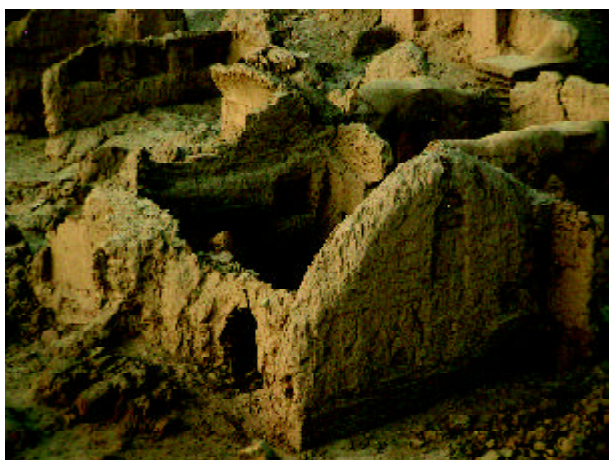
Figure 11. Unrestored ruins in the Konari neighborhood of the Arg-e Bam that survived the earthquake with comparatively little damage.

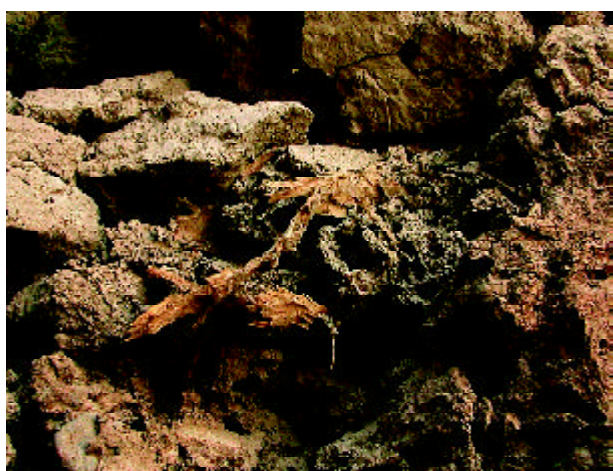
Figure 12. View of section of earthquake-caused collapse showing timber consumed by termites.

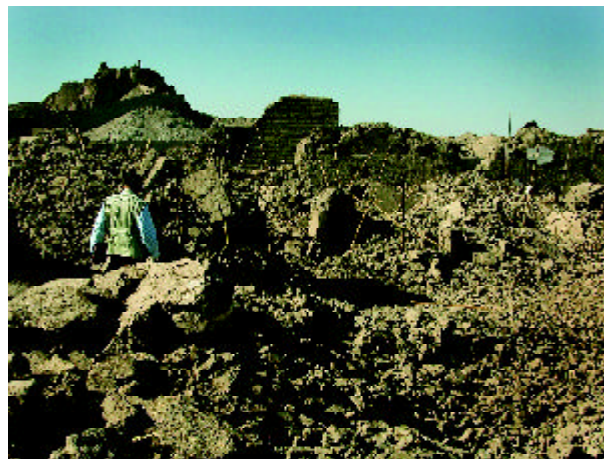
Figure 13. Ruins of the Grand Mosque. The north-west section of the main courtyard was on the right side of the view.

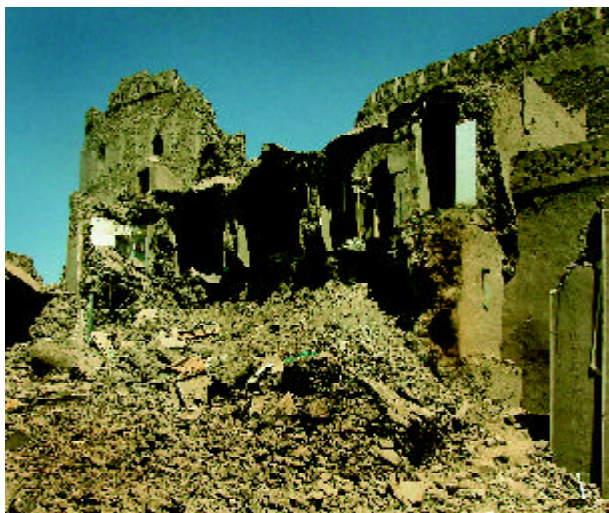
Figure 14. Buildings above the Stables courtyard that collapsed from the lateral spreading failure of the retaining wall and fill beneath.

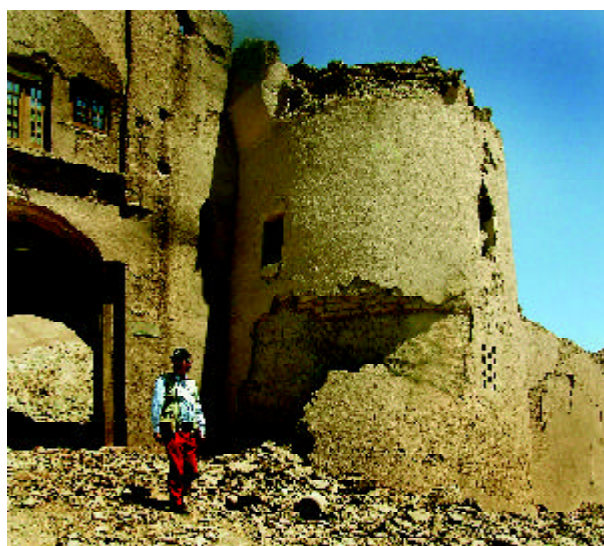
Figure 15. One of the few surviving turrets has a room in its base, as shown by the ground floor window. The floor diaphragm timbers extend through the walls, and are now visible after the stucco fell off. The collapsed masonry and stucco is from what appears to be a modern-day modification of the shape of the tower in the tradition of Viollet-le-Duc. The tower's original surface underneath is intact.

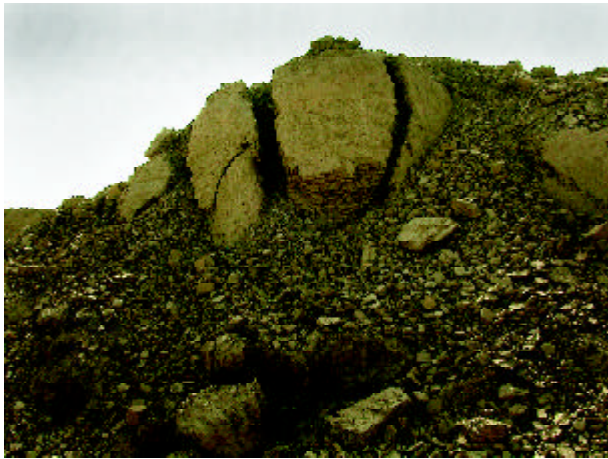
Figure 16. Collapsed round turret on the ramparts that shows evidence of having burst apart from collapse of internal layers.

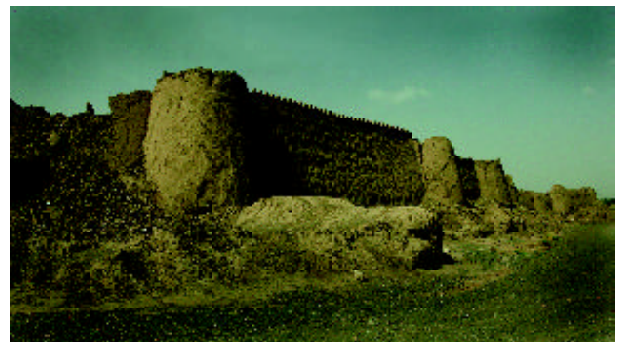
Figure 18. North-facing ramparts that were significantly less damaged in the earthquake than the other city walls. Notice that the crenellations are still intact on this one section, the only section where that was observed to be the case.

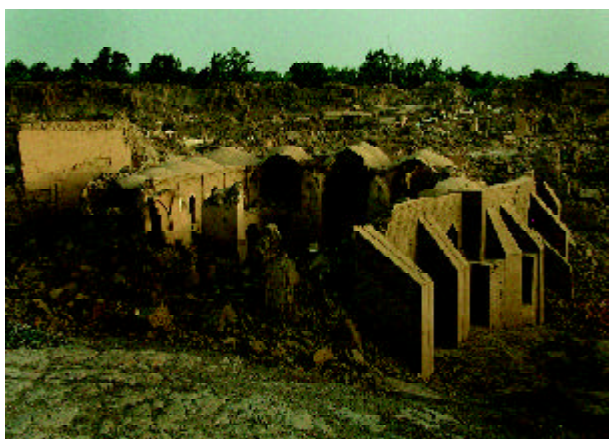
Figure 19. The ruins of the Caravansary show that the domed rooms on the second level behind the buttresses have collapsed, while the ones opposite still remain. There are no buttresses behind the external wall of the opposite side. The base of the 5th buttress is crushed.

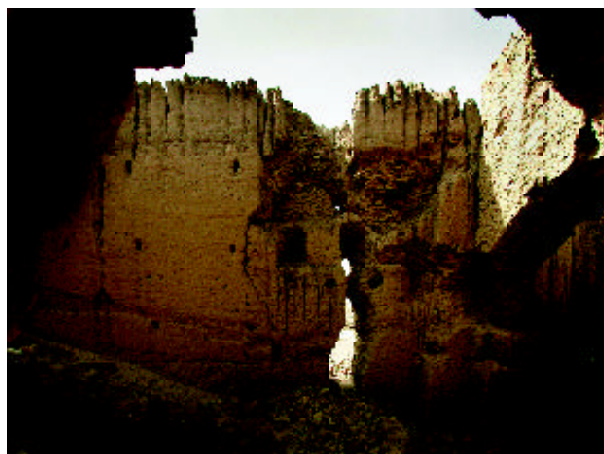
Figure 20. The interior of the unrestored "Shahrbast Wall" showing 3-story high walls that survived the earthquake. Notice the older section with later work constructed around it. This is a good example of the onset of damage at the interface of construction of different age and type, as a small area of collapse has revealed this interface. Notice the debris on the ground.

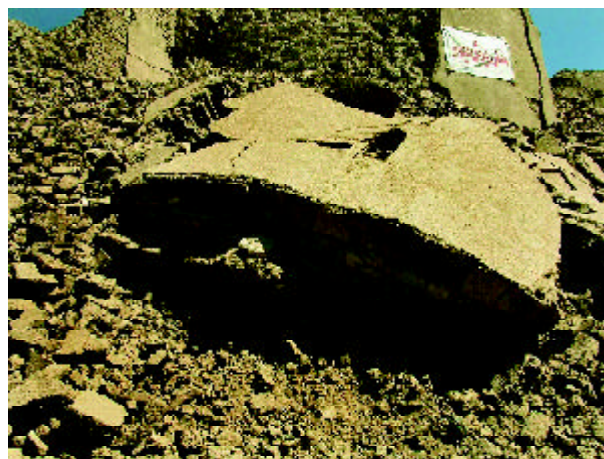
Figure 22. Collapsed section of the main gateway showing imbedded timber reinforcement of the Khesht wall.

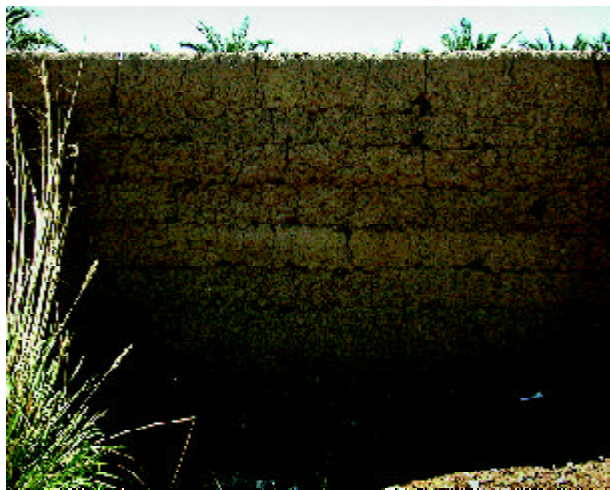
Figure 23. Chineh garden wall, probably of recent origin, in Baravat (near to Bam). This wall shows the cracks that commonly exist in chineh walls, and how the layered construction helps to ensure stability by allowing the cracked sections of the mud layers to perform like large blocks of masonry.

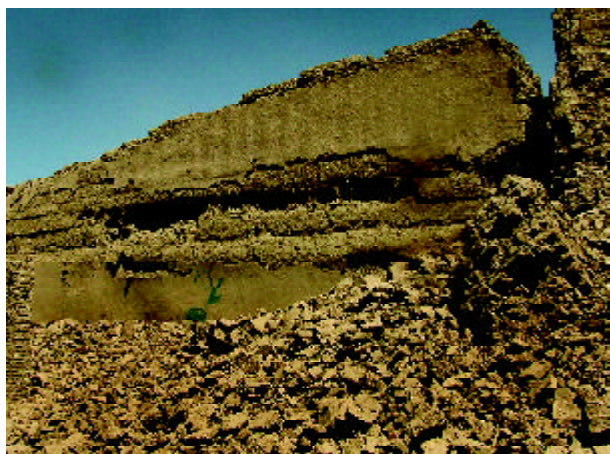
Figure 24. South-facing outside wall of the stables courtyard showing how the layering of the chineh walls has interrupted the cracking and collapse of sections of the wall, thus helping to maintain the stability of the partly undermined upper part of the wall.

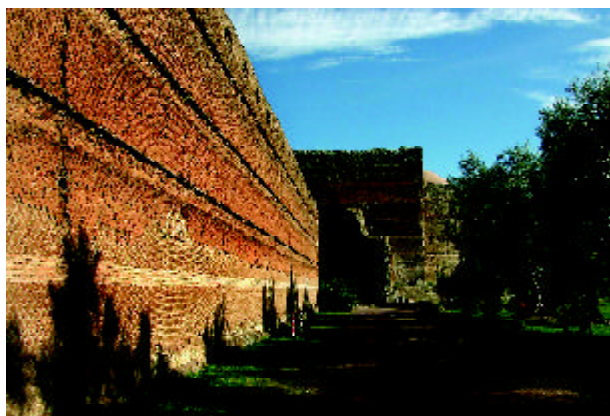
Figure 25. Long Wall, Hadrian's Villa near Rome showing the bands of brick that were laid into a wall constructed with natural cement with a tile facing. The crevices are the result of the later chipping out of the bricks for re-use.

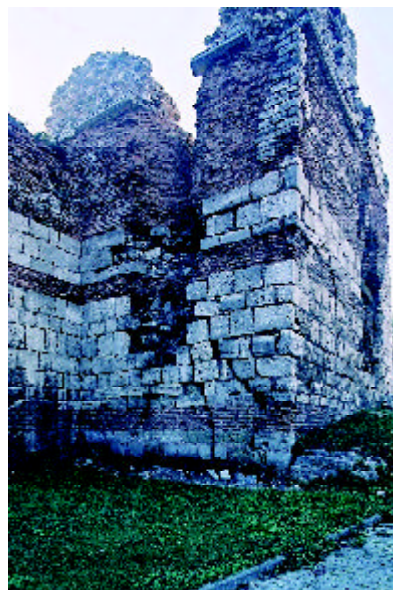
Figure 26. Surviving portion of the original Istanbul city walls. The cracks and broken section pre-dated the 1999 earthquake.

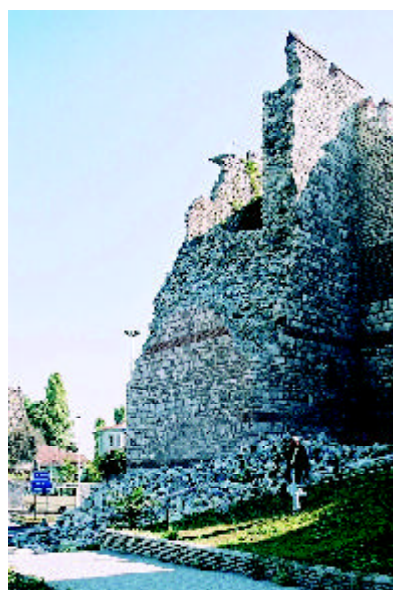
Figure 27. The reconstructed tower that collapsed during the 1999 earthquake. The bands of red brick on the wall were fake veneers, rather than full layers.

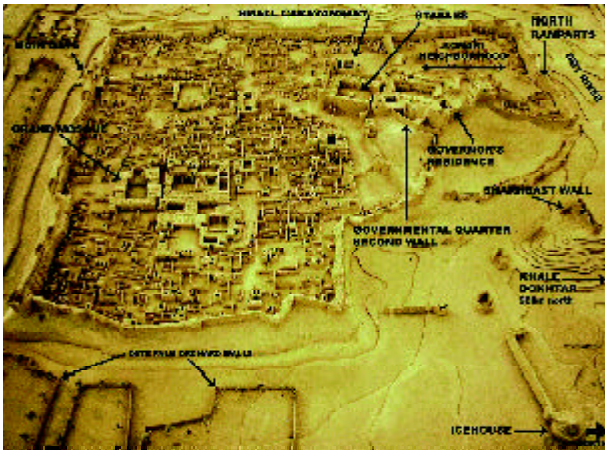
Figure 29. ICHO model of the Arg-e Bam after recent restorations prior to the earthquake.
