A Study on Safety of Reconstructed Regions after 1990 Rudbar-Manjil Earthquake in Iran

Kiarash Nasserjadi

Assistant Professor, University of Zanjan, Zanjan, Iran, nasserjadi@znu.ac.ir and Member of Iranian Earthquake Engineering Association

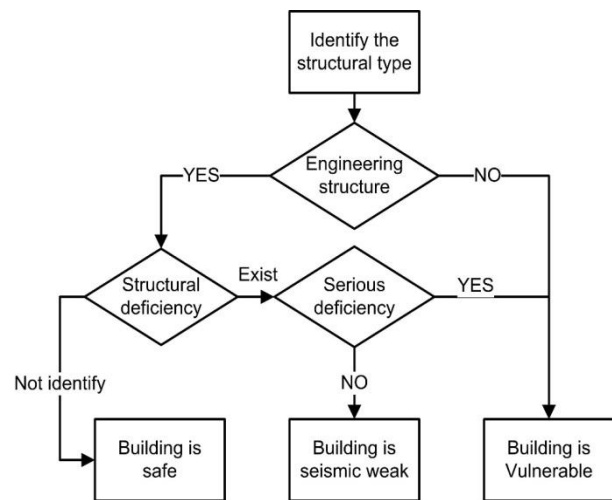
Figure 2. The flowchart of simplified seismic evaluation methodology, modified according to FEMA-154 [16].

Given the fact that limited structural types have existed in the study area and fall into two main categories of engineering and non-engineering, the FEMA-154 methodology can be followed in a more simplified procedure as shown in Figure (2). The "base score" of non-engineering structures are lower than the acceptable level in the FEMA-154 methodology, which is expressed by "cutoff score" (see Table 1). Therefore, these buildings can be considered as "vulnerable". The engineering structures possess enough "base score" but may have other problems, making them vulnerable. This type of vulnerability cannot be identified in FEMA-154 methodology. Thus, they are considered for other phases of evaluation. In the first phase, the deficiencies in the general configuration of structures are examined (e.g. the integrity of the lateral load carrying system, irregularity, etc.) and those with no deficiencies

are classified as safe. In the second phase, the structure with no serious deficiencies is categorized as weak, the rest are considered as vulnerable. Serious deficiency can be described as: 1) missing the element or discontinuity in the lateral load system, 2) obvious mistakes in design and detailing, and 3) missing vertical ties in confined masonry buildings. A weak building in this study is a building, categorized as safe in FEMA-154, but due to some minor errors, incapable of being identified by the methodology, cannot be considered as an absolutely safe building. The results of vulnerability evaluation are shown in the following section.

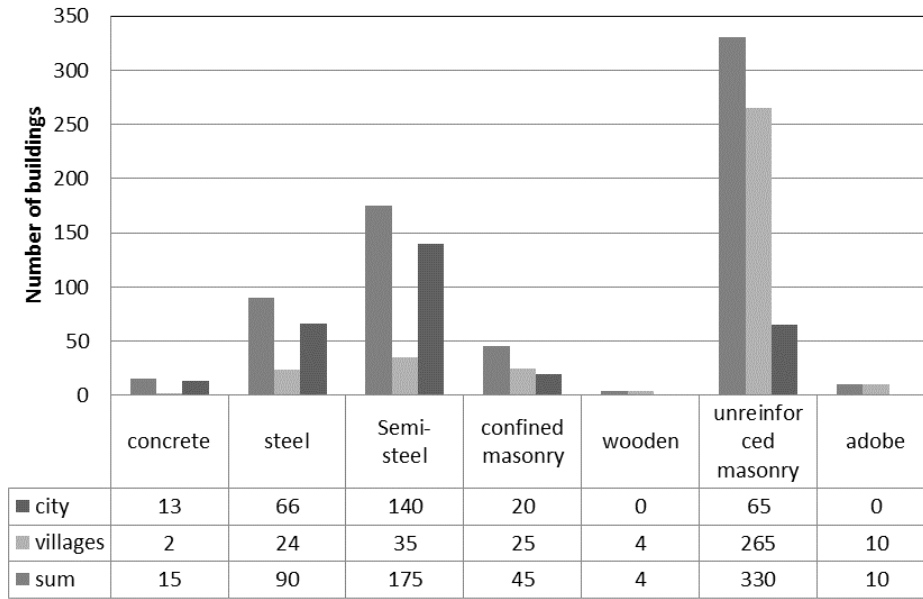
Figure 3. Number of observed buildings in the survey and their classifications based on their locations and structural taxonomies.

A total number of 669 houses (304 in cities and 365 in villages) were surveyed in the region, comprising several structural types shown in Figure (3). The most observed forms of structures were:

unreinforced masonry, semi-steel, and steel. This figure varies between the villages and cities. Dominating types were unreinforced masonry and semi-steel in the villages and cities respectively, whereas the least structural types were adobe and wooden, abandoned after the earthquake. Generally, more than 84% of houses can be considered as non-engineering structures.

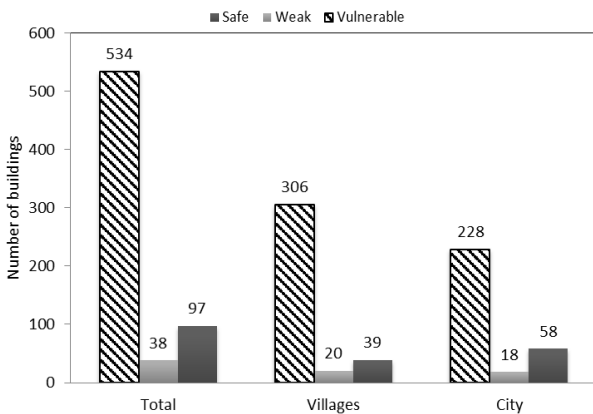
Figure 4. Number of safe, weak and vulnerable buildings, observed in survey method in cities and villages.

Buildings' vulnerability was assessed by the simplified screening method (see Figure 2). The results from this inspection are presented in Figure (4). Results show that in total, more than 80% of observed buildings are vulnerable to an earthquake similar to 1990 Rudbar-Manjil, which is almost comparable to 84% percentage of non-

engineering buildings in the region shown in Figure (3). The figure is higher in villages, about 83%, and about 75% in cities. This level of vulnerability suggests that the recovery after the event do not provide an acceptable safety level for the region and the development is not sustainable. It means that, again, significant losses are expected in any future earthquake.

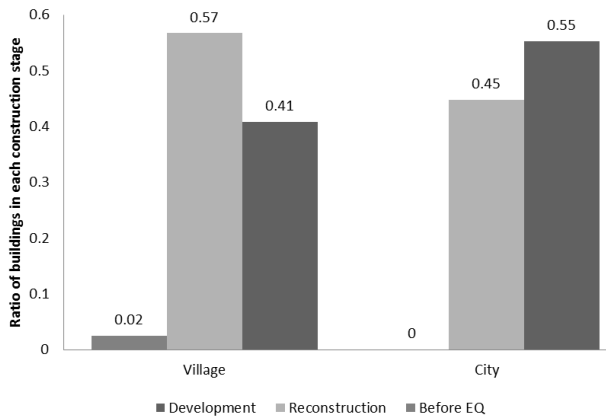
Figure 5. Ratio of observed buildings in different construction periods in cities and villages.

The ratio of buildings in each time zone is shown in Figure (5). According to the figure, it can

be concluded that half of the observed buildings are constructed during the recent years and most of the new buildings are located in the cities. Figure (6) shows the ratio of vulnerable buildings in different construction periods. It is shown that almost all of the buildings were built during

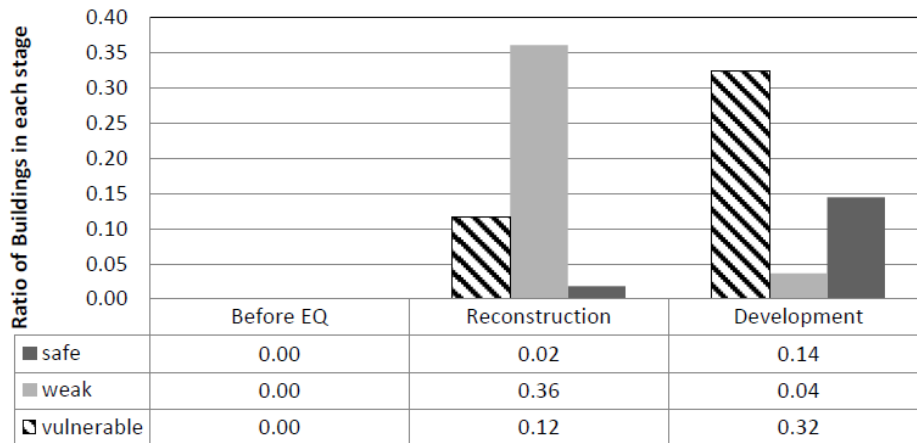
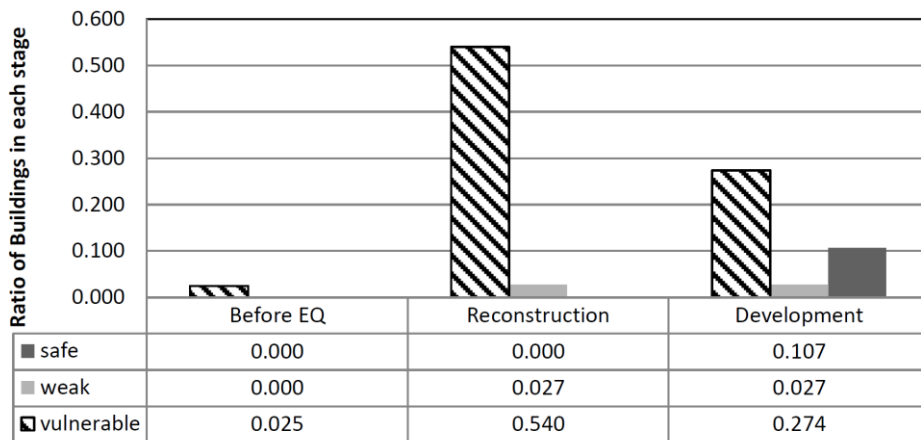
(a) In Cities

(b) In Villages

Figure 6. Ratio of observed buildings' vulnerability in different construction periods.

"reconstruction period" and most of them, which are built in the "development period", are vulnerable. In addition, it can be observed that safety of recent houses has been increased, but still the ratio of vulnerability is quite high. This indicates that the culture of safe construction has not been implemented in the region.

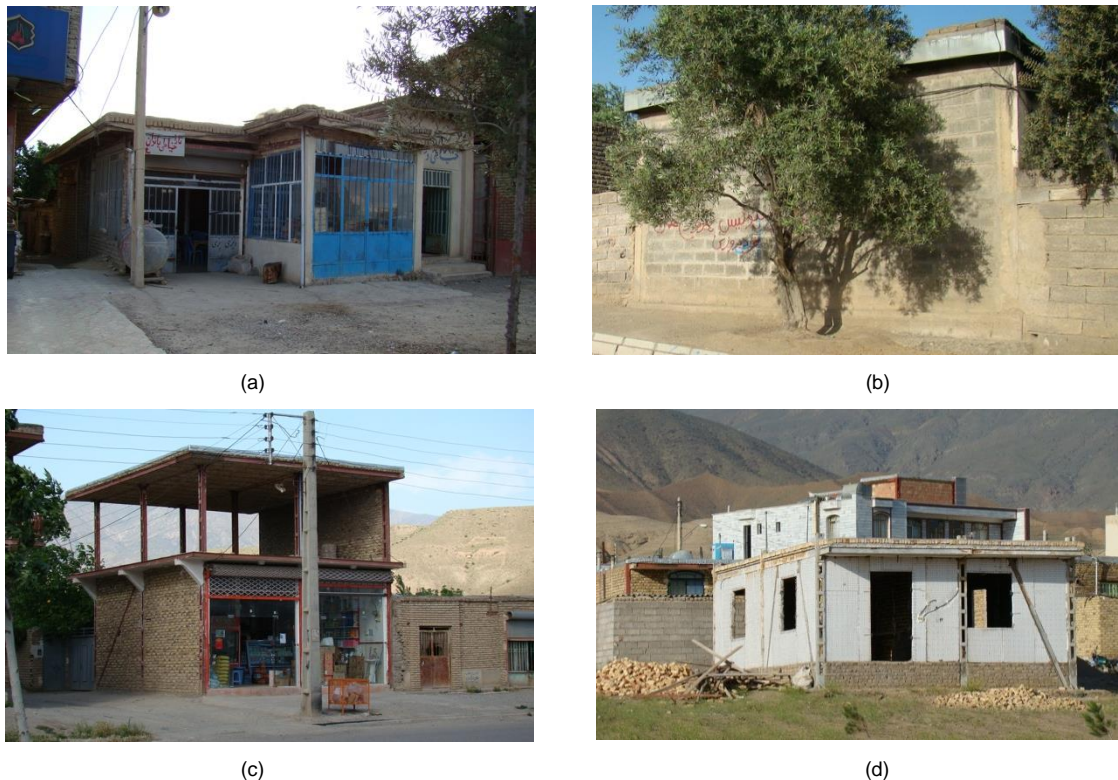
Examples of buildings in urban areas are shown in Figure (9). "a" and "b" are built during the "reconstruction period", and "c" and "d" are built in the "development period". "a" presents a vulnerable steel structure without any proper lateral resistant system. "b" shows a confined masonry structure constructed according to the code of practice for seismic design of its time. Since most of the regulations for this type of the construction still exist in the code, this building can be considered as safe. "c" is a vulnerable steel structure with significant mistakes: 1) missing bracing in the second floor and 2) significant irregularity in brace location in the first floor. "d" illustrates a typical steel structure with bracing with minimum seismic resistant requirement. It is classified as safe.

Figure 9. Sample of observed buildings in cities in different construction period. a) A vulnerable steel structure without any proper lateral resistant system; Constructed in reconstruction period, considered as vulnerable structure. b) Confined masonry structure with proper vertical and horizontal ties; Constructed in reconstruction period, considered as a safe structure. c) A steel structure with lack of bracing in second floor and vertical irregularity; constructed in developing period and considered as vulnerable. d) A well-constructed steel structure built in developing stage, considered as safe.

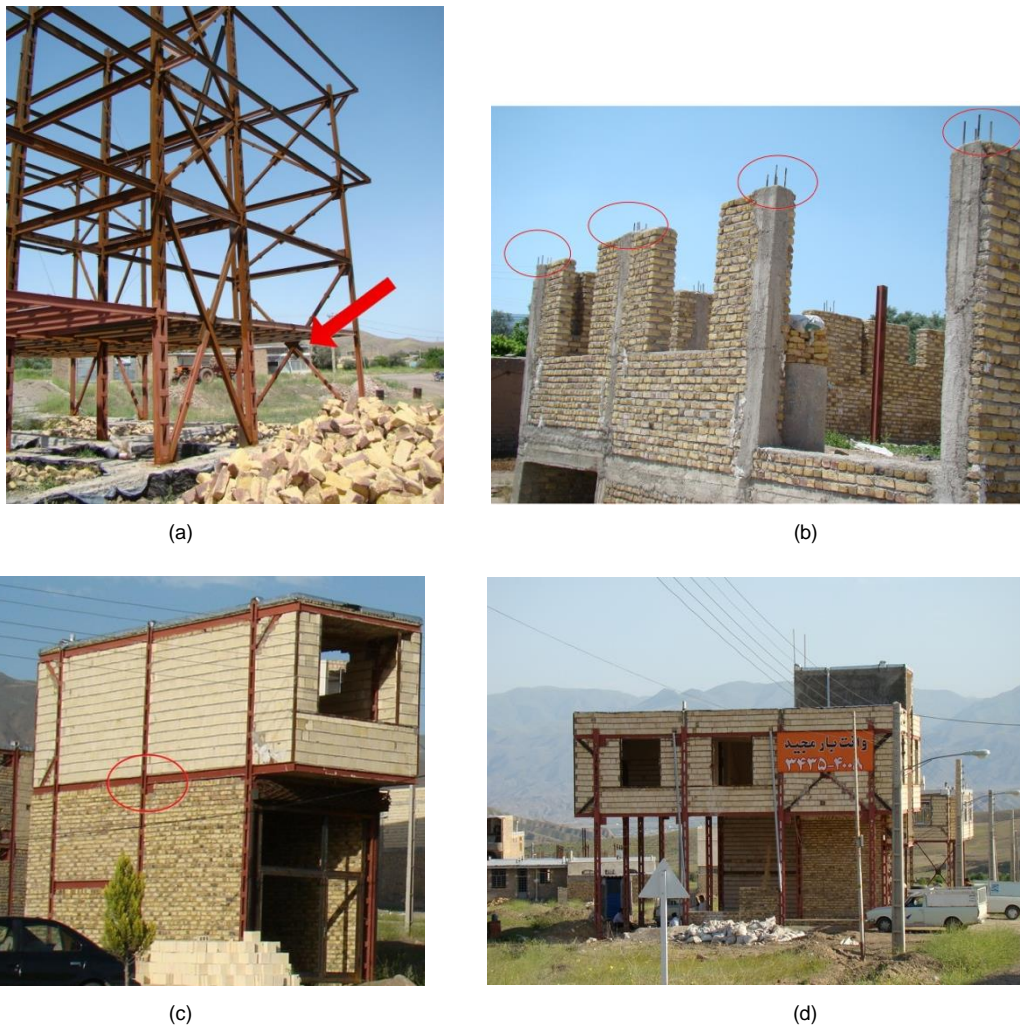
Figure 10. Samples of mistakes in the new and vulnerable constructions: a) An under-construction four-story steel braced structure is shown. The braces did not connect to the first floor so the first floor does not have the lateral load system (shown by arrow in the figure). b) A two-story confined masonry under-construction structure is shown. Inadequate anchorage length of reinforcement in vertical ties has been observed. This creates weak joints in ties and causes damages in an earthquake. c) A two-story steel structure is shown. The gusset plates for braces installed in the columns (shown by circle), but no brace was installed for this building. d) A two-story braced steel structure is shown. The missing braces in the first floor are observed.

As it is shown in Figure (7), the majority of new buildings are vulnerable because serious errors in the design and/or construction exist. Four samples of such structures have been shown in Figure (10). These mistakes are just taken from some of the most obvious cases and many more detailed shortcomings have been observed that cannot be covered here.

The main explanation for the vulnerability of buildings built in the "development period" is basic mistakes in the design and buildings' construction. This is directly related to a lack of well-trained local engineers as well as limited number of qualified workers to apply the new construction technology. In other words, two decades after the introduction of design code, training of engineers, and different code enforcement organizations, a good construction practice does not exist in the region. This is a proof for poor organized system in the region.
