# Performance of Batten Columns in Steel Buildings During the Bam Earthquake of 26 December 2003

**B. Hosseini Hashemi and M. Jafari S.**

Structural Engineering Research Center, International Institute of Earthquake Engineering and Seismology (IIEES), Tehran, Iran, email: behrokh@iiees.ac.ir

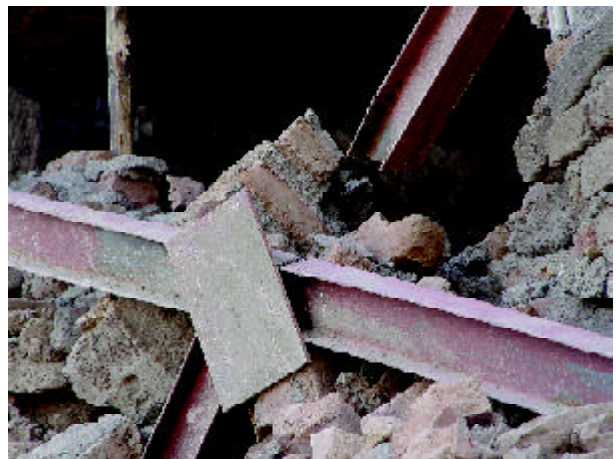
Figure 3. Rupture of connections in concentrically X bracing.

common type of bracing in steel braced frames in Bam. The observed failure modes in these braces were out of plane buckling and rupture of connections. The major reasons for these failures were construction defects and incomplete welding of connections. Some examples of bracing failures are shown in Figures (3) and (4).
