# The Behavior of Special Structures During the Bam Earthquake of 26 December 2003

Sassan Eshghi and Mehran Seyed Razzaghi

Structural Engineering Research Center, International Institute of Earthquake Engineering and Seismology (IIEES), Tehran, Iran, email: s.eshghi@iiees.ac.ir

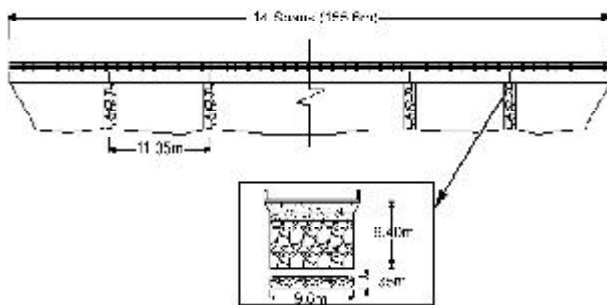
In general, bridges sustained little or no damage. The most affected bridge, Espikan Bridge north of Bam near Arg-e Bam, sustained little damage. Espikan Bridge is a uniform bridge with an RC deck and stone masonry columns and 14 spans across the Poshtrood River, see Figure (10). As shown in Figure (11), the RC bent caps of the bridge cracked with the longitudinal movement of the deck in the north-south direction. No visible damage occurred to

**Figure 10.** Espikan Bridge.

the deck slab as a result of the pounding of separate parts of the superstructure thanks to sufficient joint width and the bridge was in service after the earthquake.
