Reconnaissance Report on Building Damage Due to Bam Earthquake of 26 December 2003

Yasushi Sanada¹, Masaki Maeda², Ali Niousha³, and M. Reza Ghayamghamian⁴

ABSTRACT: *The post earthquake investigations of the 26 December 2003 Bam-Iran earthquake were conducted by the Joint Reconnaissance Team of the Architectural Institute of Japan (AIJ), the Japan Society for Civil Engineers (JSCE), the Japan Association for Earthquake Engineering (JAEE) and the Ministry of Education, Culture, Sports, Science and Technology (MEXT) in collaboration with the International Institute of Earthquake Engineering and Seismology (IIEES). This paper reports the results of the AIJ team on damage evaluation of the buildings around the Bam strong motion station operated by the Building and Housing Research Center (BHRC). The seismic capacity of damaged buildings was approximately estimated. The results show that many residential houses in the investigated area were seismically vulnerable structures such as adobe and simple masonry structures. Poor construction quality was also found in some of the investigated buildings designed according to the current Iranian seismic code. Moreover, good correlation betwee

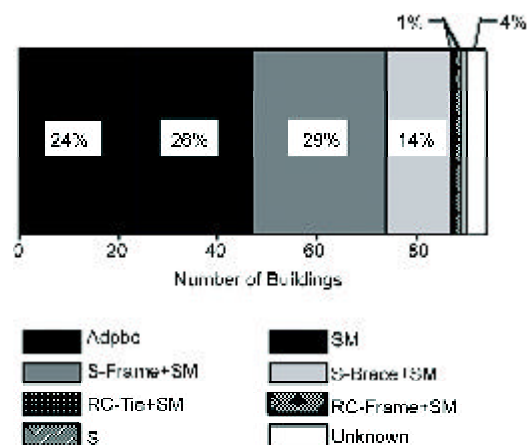
Figure 3. Distribution of structural systems.

Figure (3) shows the distribution of the structural systems in the investigated area. The distributions of usages of Adobe, *SM*, *S-frame+SM*, and *S-brace+SM* buildings, which occupy 90% of all 94 buildings in this area, are shown in Figure (4). The ratios of

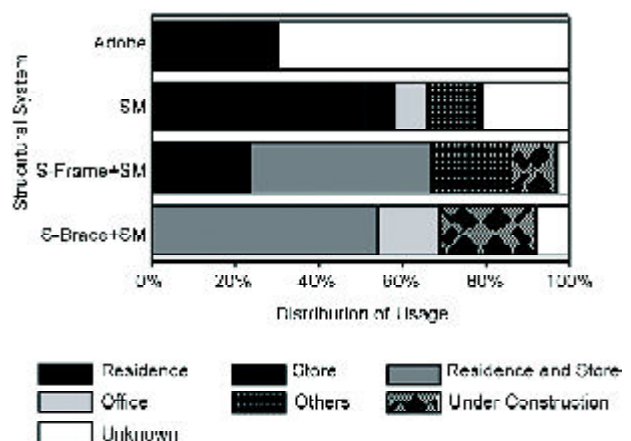
Figure 4. Distributions of usage of major structural systems.

S-frame+SM and *S-brace+SM* buildings, which were mainly used for residence and store buildings, are large as those of Adobe and *SM* buildings, which were mainly used for residential buildings, because the investigated area is located in the center part of the city.

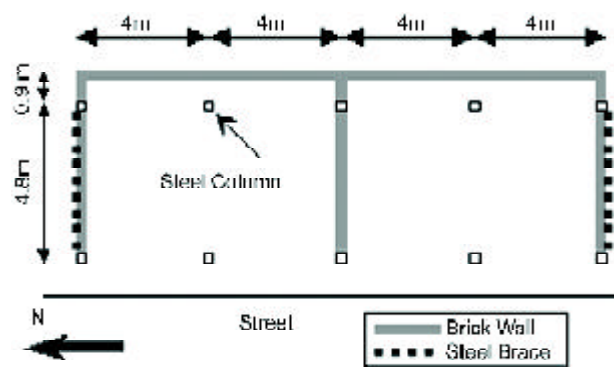
Figure 15. First floor plan.

The under construction building, see Photo (7) is located a few hundreds meter south of Governor's Building. The structural system of this building is quite typical of the buildings along the main streets in the downtown. The three-story steel structure consists of 4 bays in *NS* direction along the street and one bay in transverse direction (*EW*) as shown in

Figure (15). Columns are erected using coupled I-shaped steel column, see Figure (16). Steel braces (I-shape, 70mmX14mm, 7mm in thickness) are installed in both exterior frames in *EW* direction. Brick walls, which are post-installed in the frame without confining by surrounding steel frame, are not expected to contribute for carrying lateral load. I-shaped steel profiles are also used for the girders and beams, see Photo (7).
